REPORT

Level One Inspection and Testing Services

Meridian Estate Stage 1, Clyde North
Lots 127 and Lots 153 to 161

Our Ref: 380735.Stage 1.v1

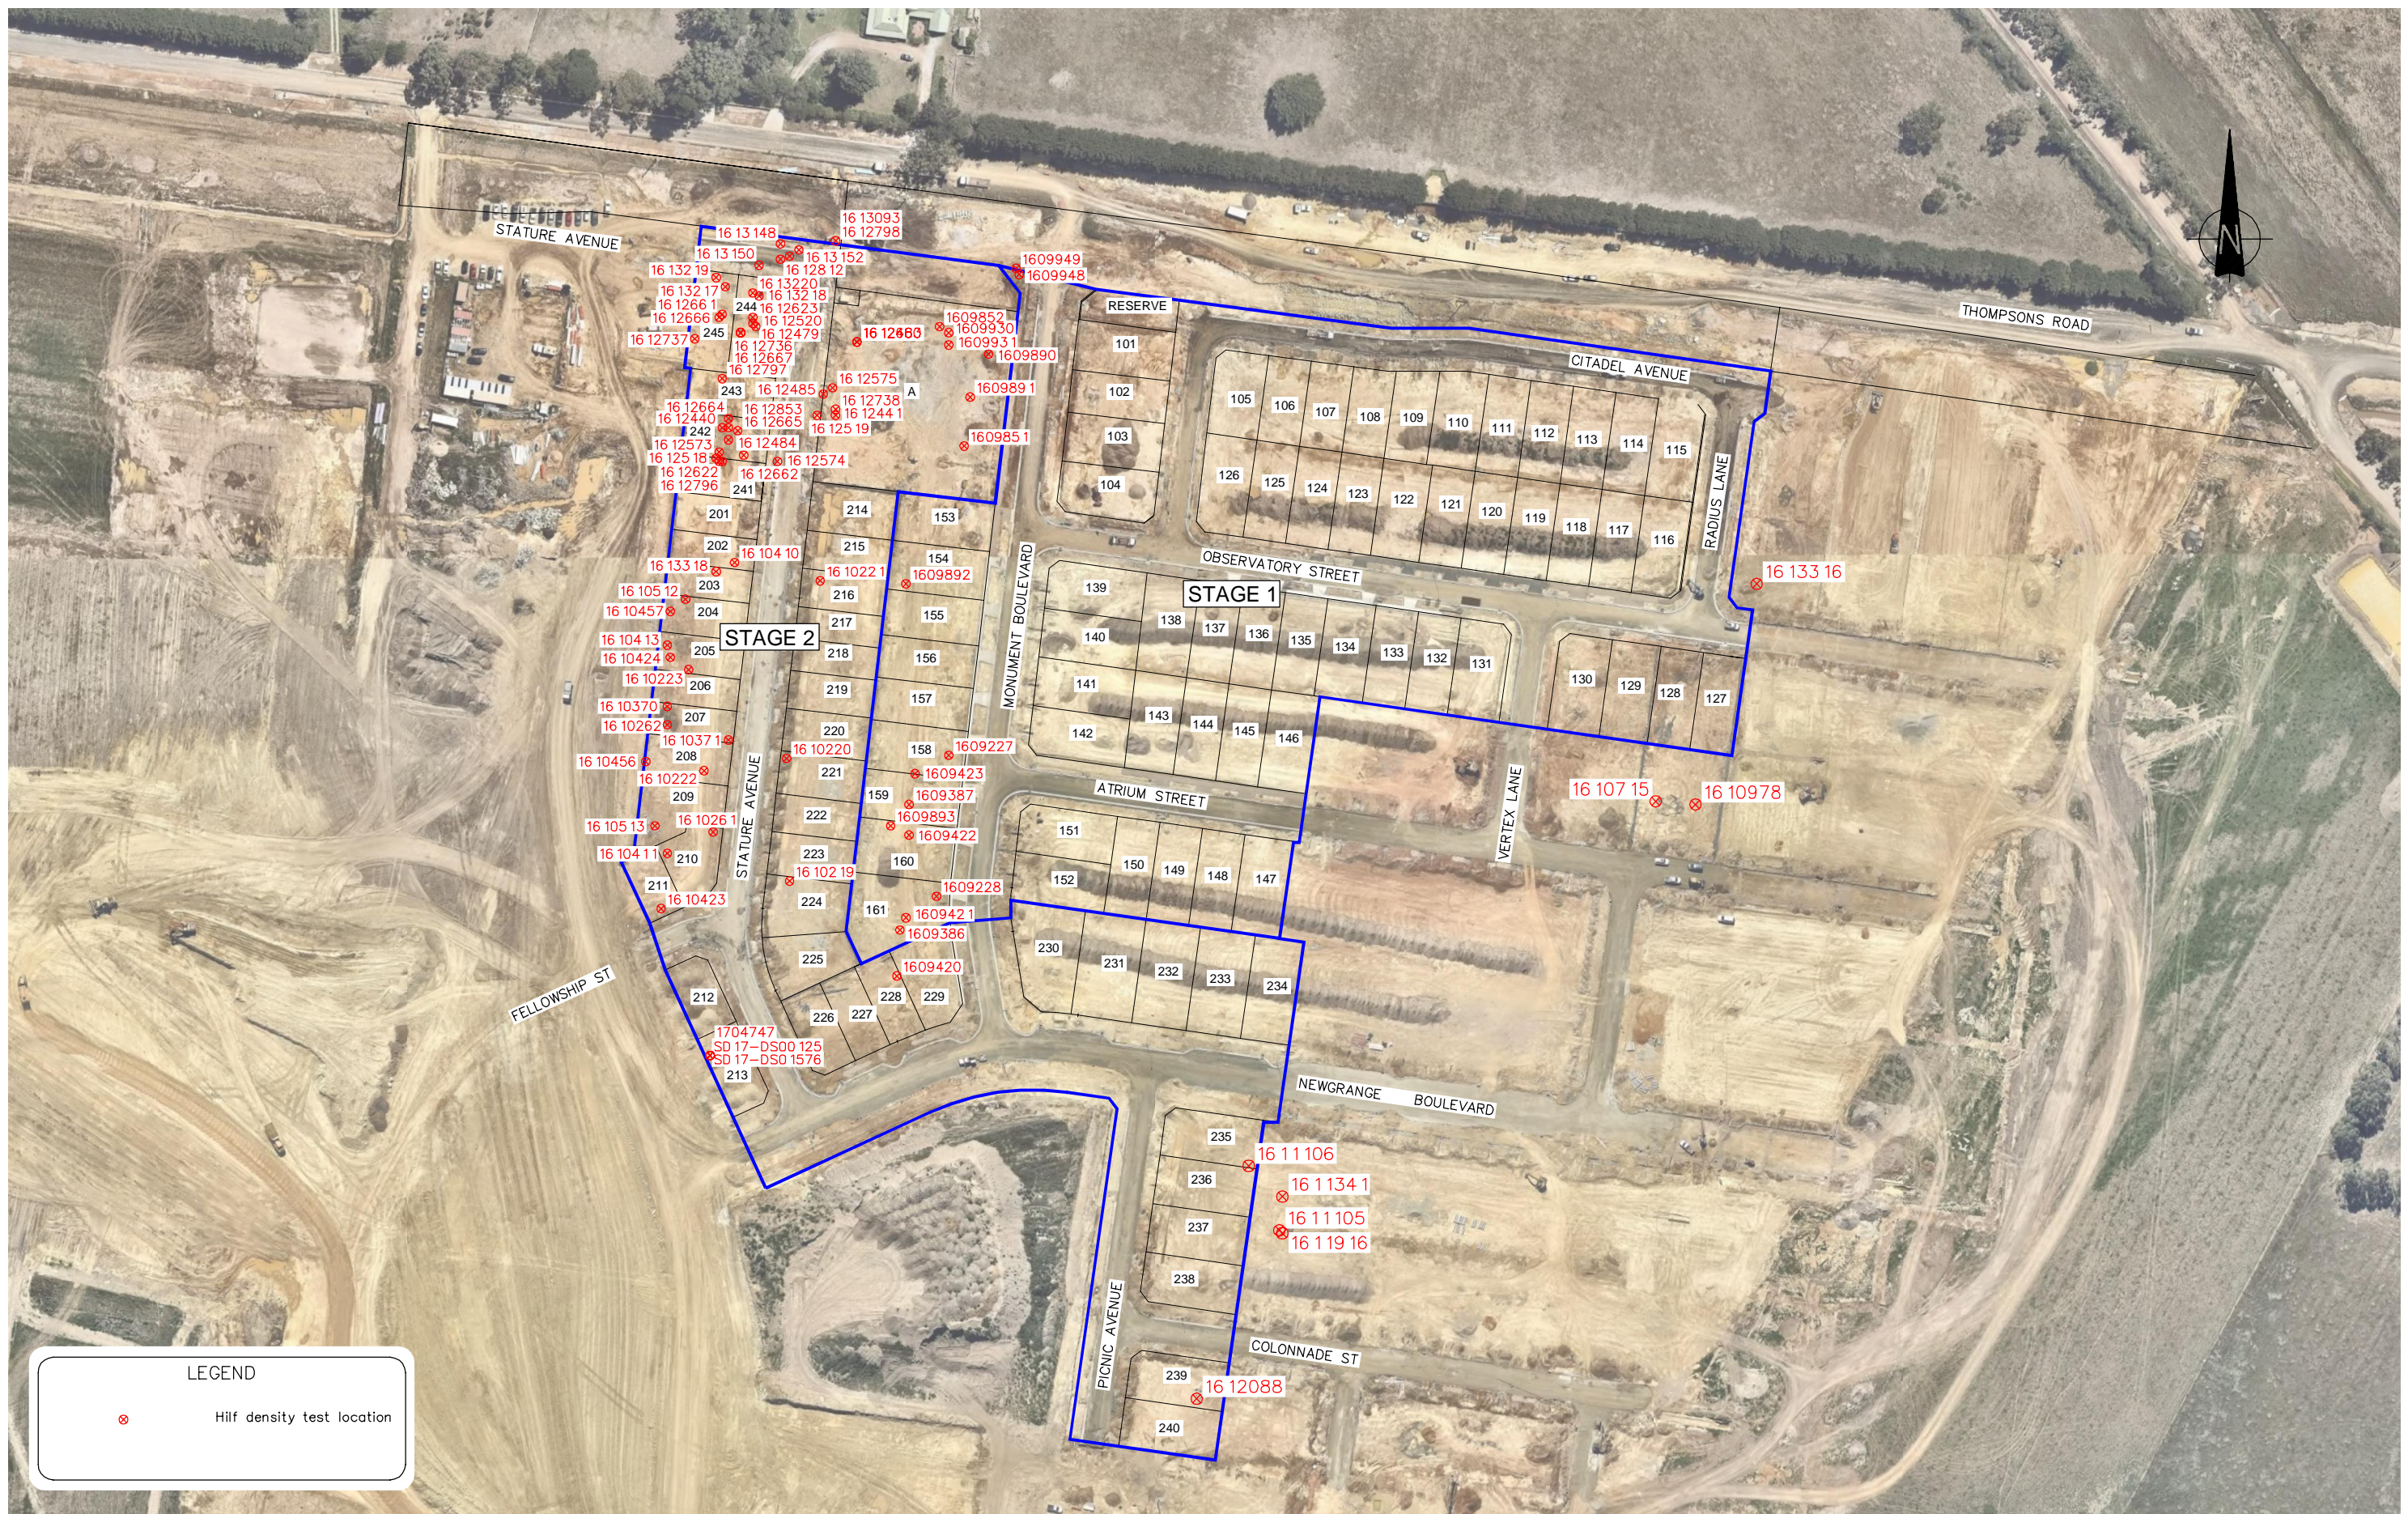
Appendix A: Density test location plan

Field density and moisture content testing was carried out using a calibrated nuclear density gauge in accordance with AS 1289.5.8.1³. The HILF rapid compaction test was used for peak converted wet density determinations in accordance with AS 1289.5.7.1. The test locations were recorded using a handheld GPS unit. A site plan showing the field density and moisture content test locations is provided in Appendix A.

The testing results show that a number of tests failed to meet the specified density and/or moisture limits. The earthworks contractor was advised of the tests that failed and the fill relevant to those areas was reworked, reconditioned, re-compacted and subsequently retested. This procedure was repeated at times until the earthwork lift was compliant with the specification requirements.
