Level One Inspection and Testing Services

Meridian Estate Stage 17, Lots 1701 to 1737

Grosvenor Lodge Pty Ltd

August 2020

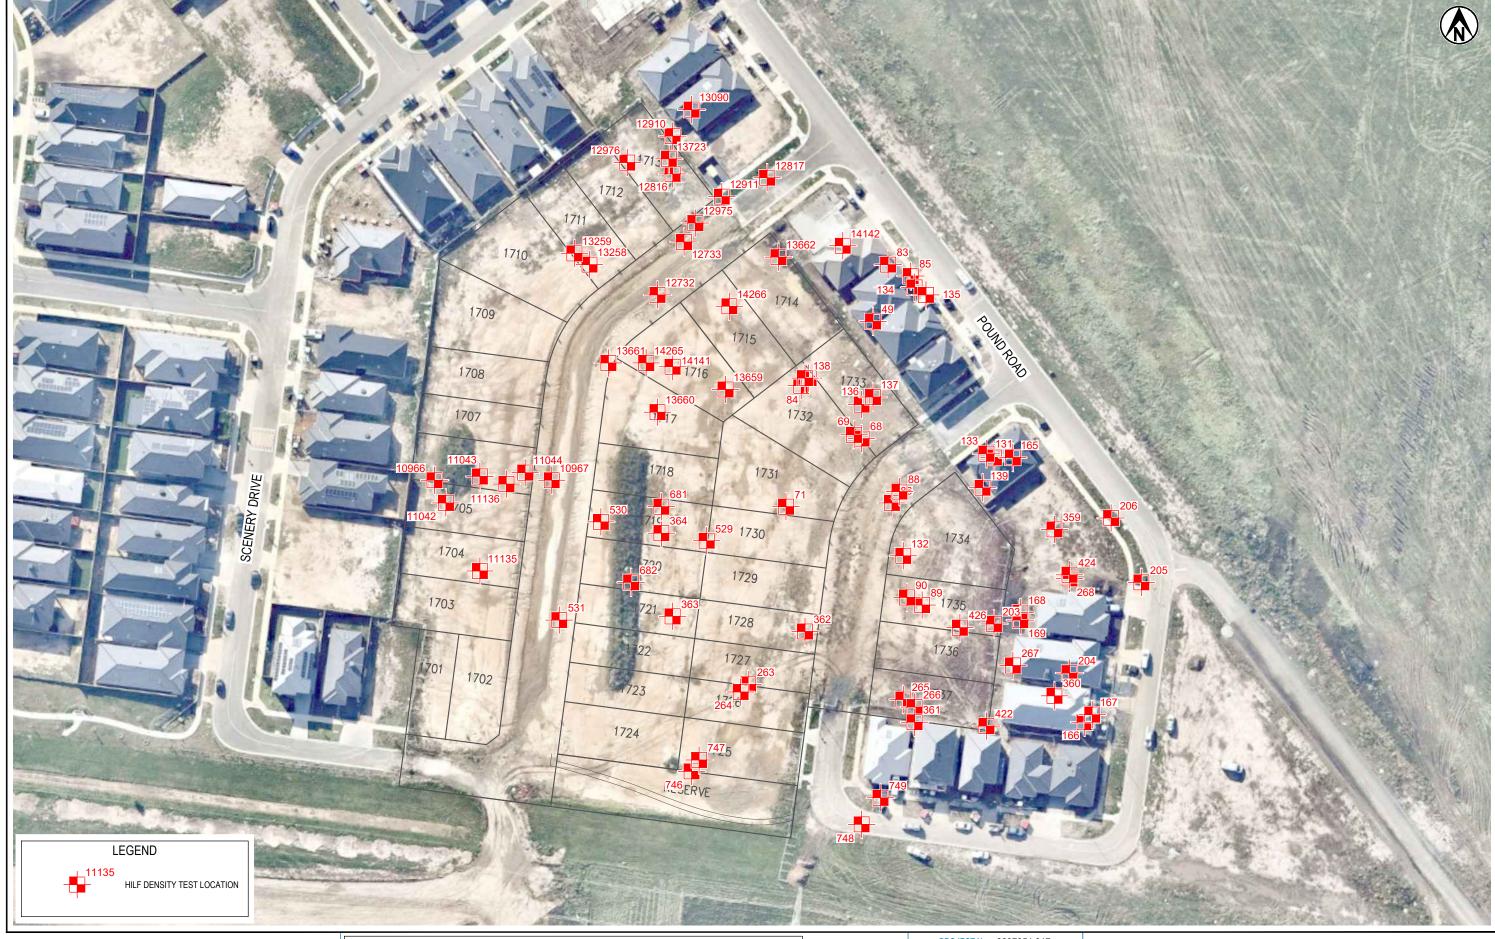
Appendix A: Density Test Location Plan

Field density and moisture content testing was carried out using a calibrated portable density and moisture gauge in accordance with AS 1289.5.8.1. The HILF rapid compaction test was used for peak converted wet density determinations in accordance with AS 1289.5.7.1. Test locations were recorded using a handheld GPS unit. A site plan showing the field density test locations is provided in Appendix A.
