Level One Inspection and Testing Services

Meridian Central Estate Stage 34, Clyde
Lot's 3406 to 3415 & Lot's 3422 to 3427

15 June 2022

Our Ref: 3807351.034.v1

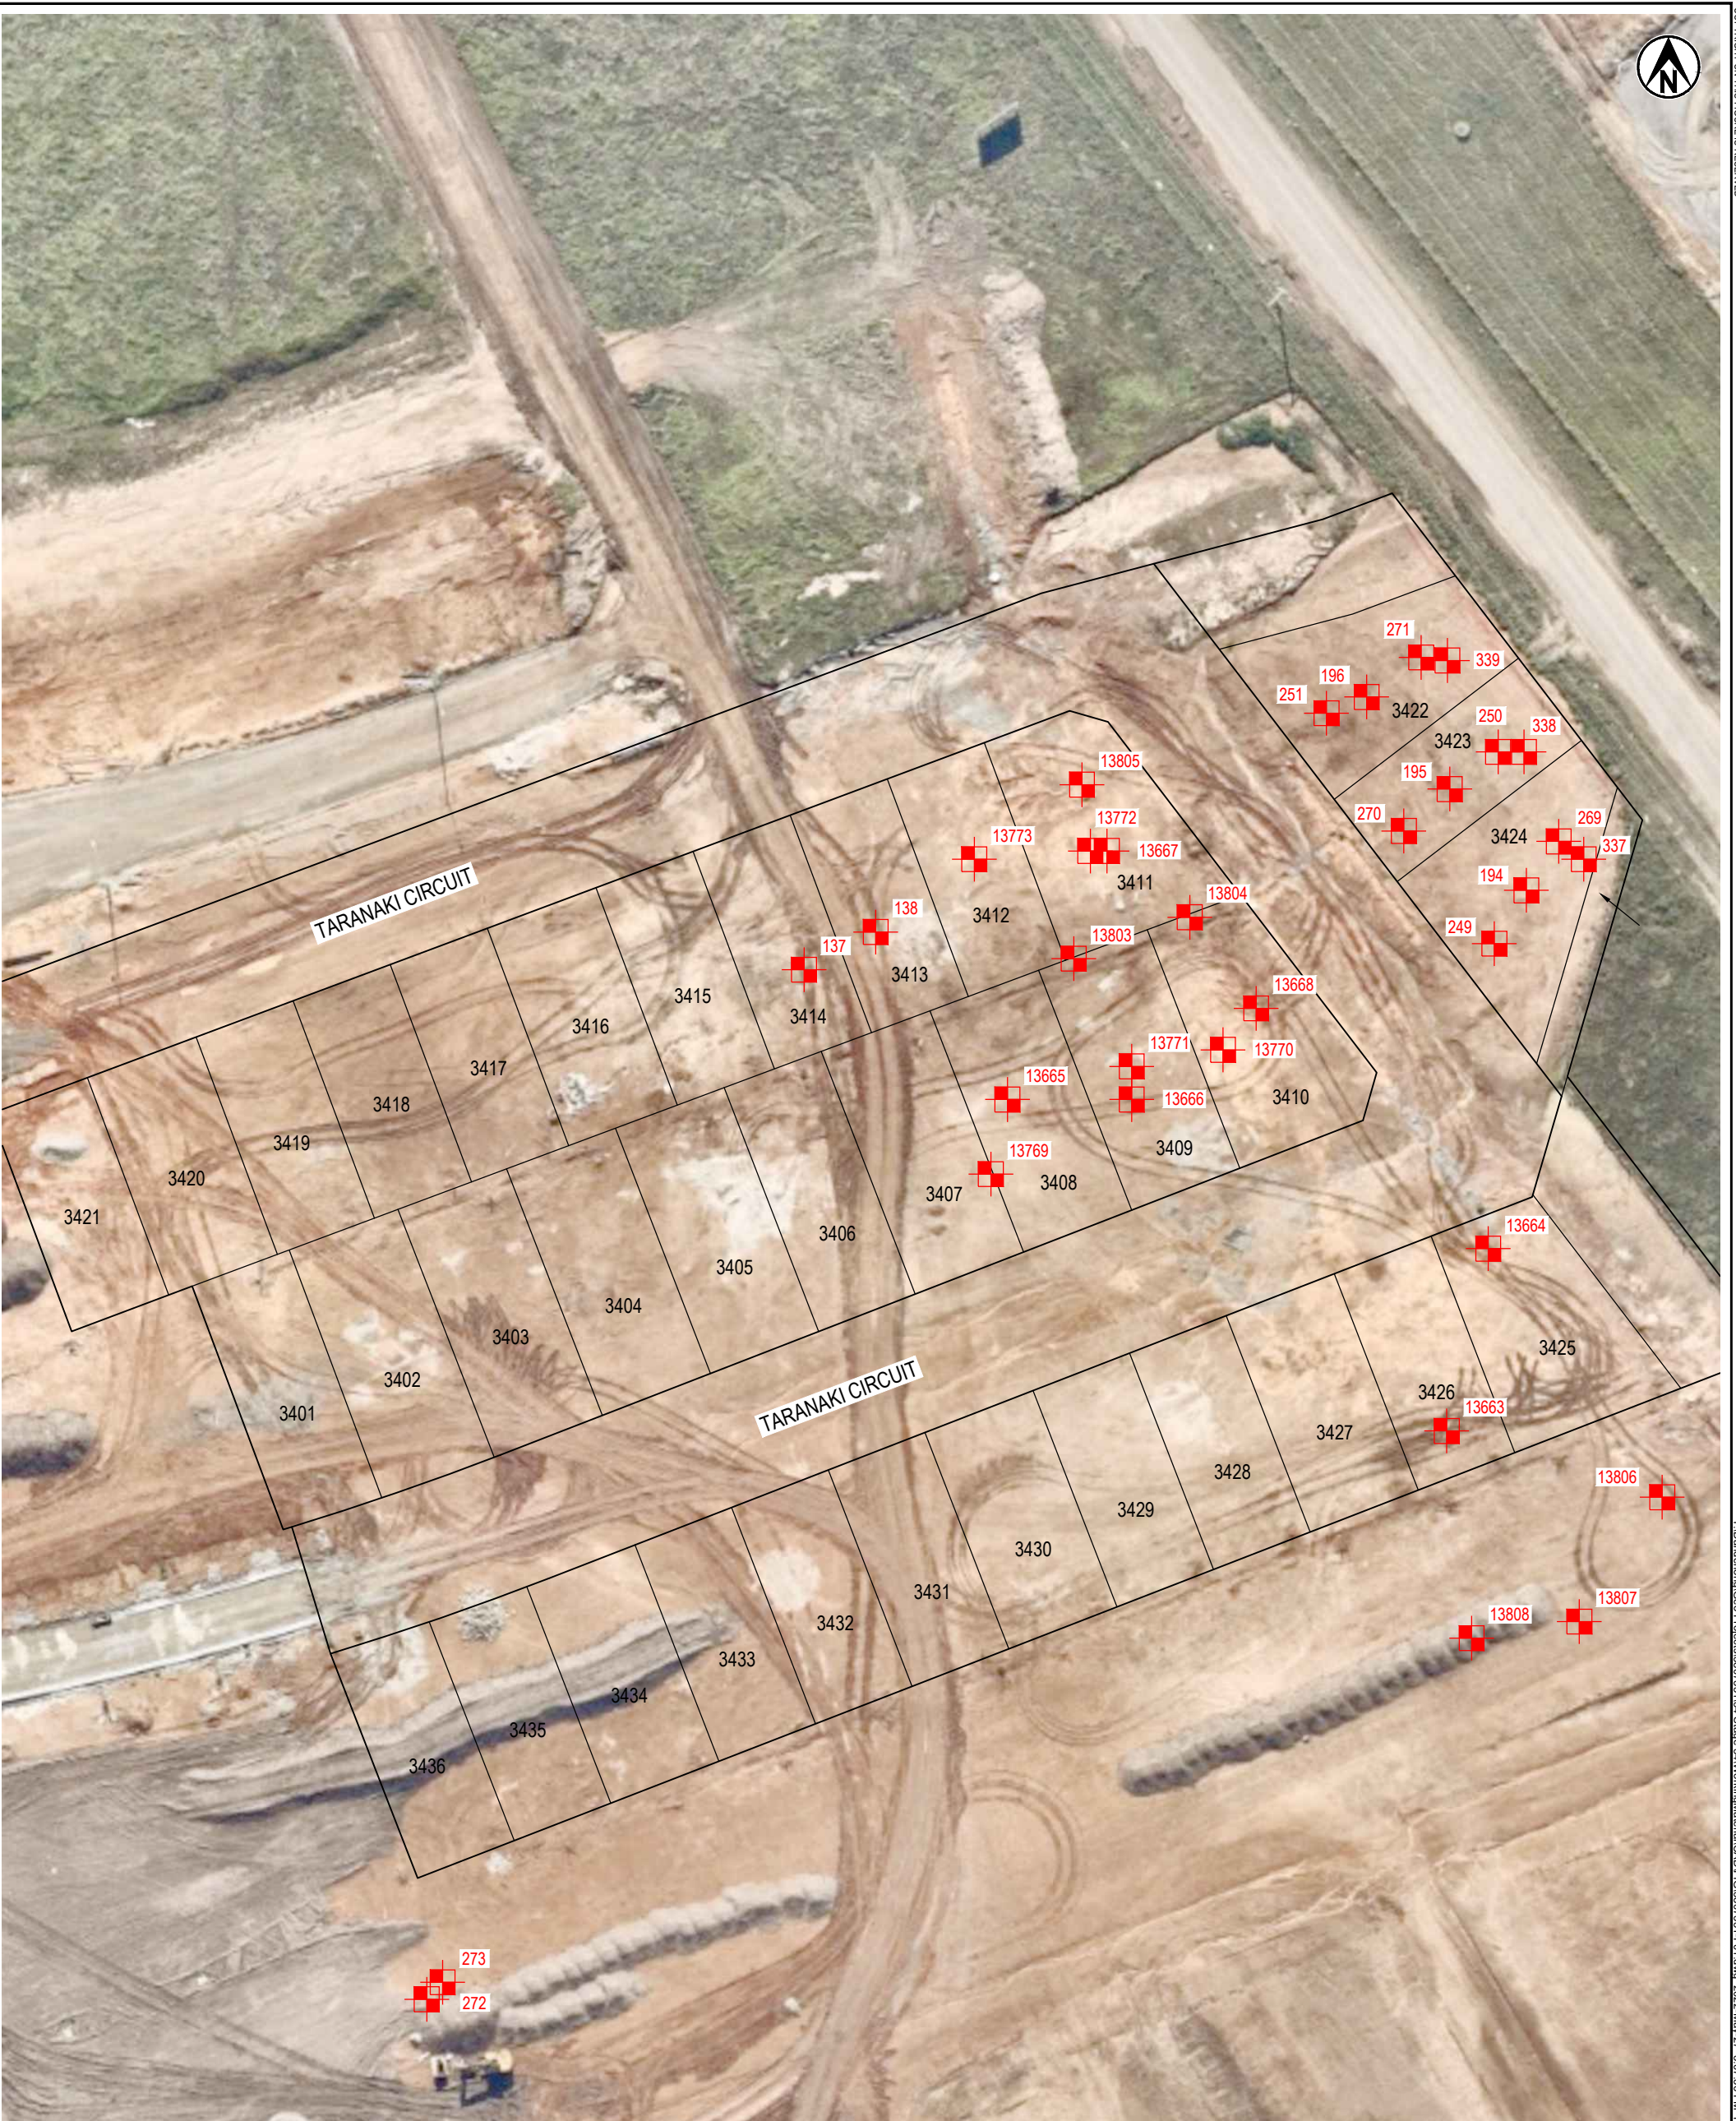
A site plan showing the field density test locations is provided in Appendix A. A summary of the Hilf density test reports is provided within Appendix B, and all the test reports are provided within Appendix C. Controlled fill certificate are provided within Appendix D.
