Level One Inspection and Testing Services

Meridian Central Estate Stage 35, Clyde
Lot 3501 & Lot's 3510 to Lot 3533

Grosvenor Lodge Pty Ltd

20 June 2022

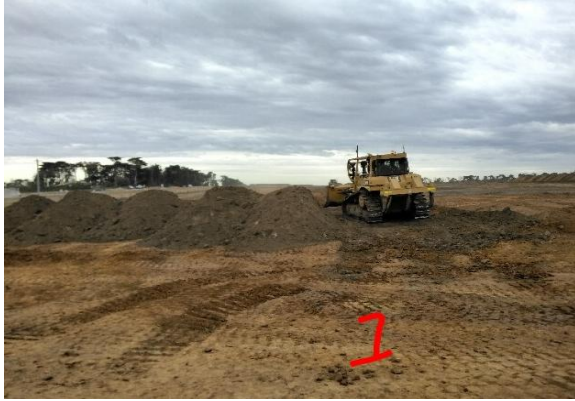
Photograph 2.7.1: Material Spreading and placement

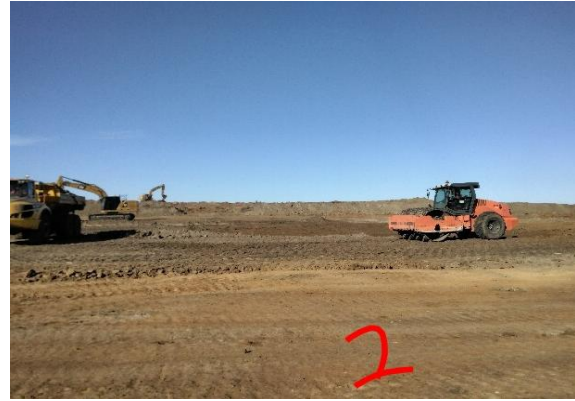
Photograph 2.7.2: Compaction with Padfoot

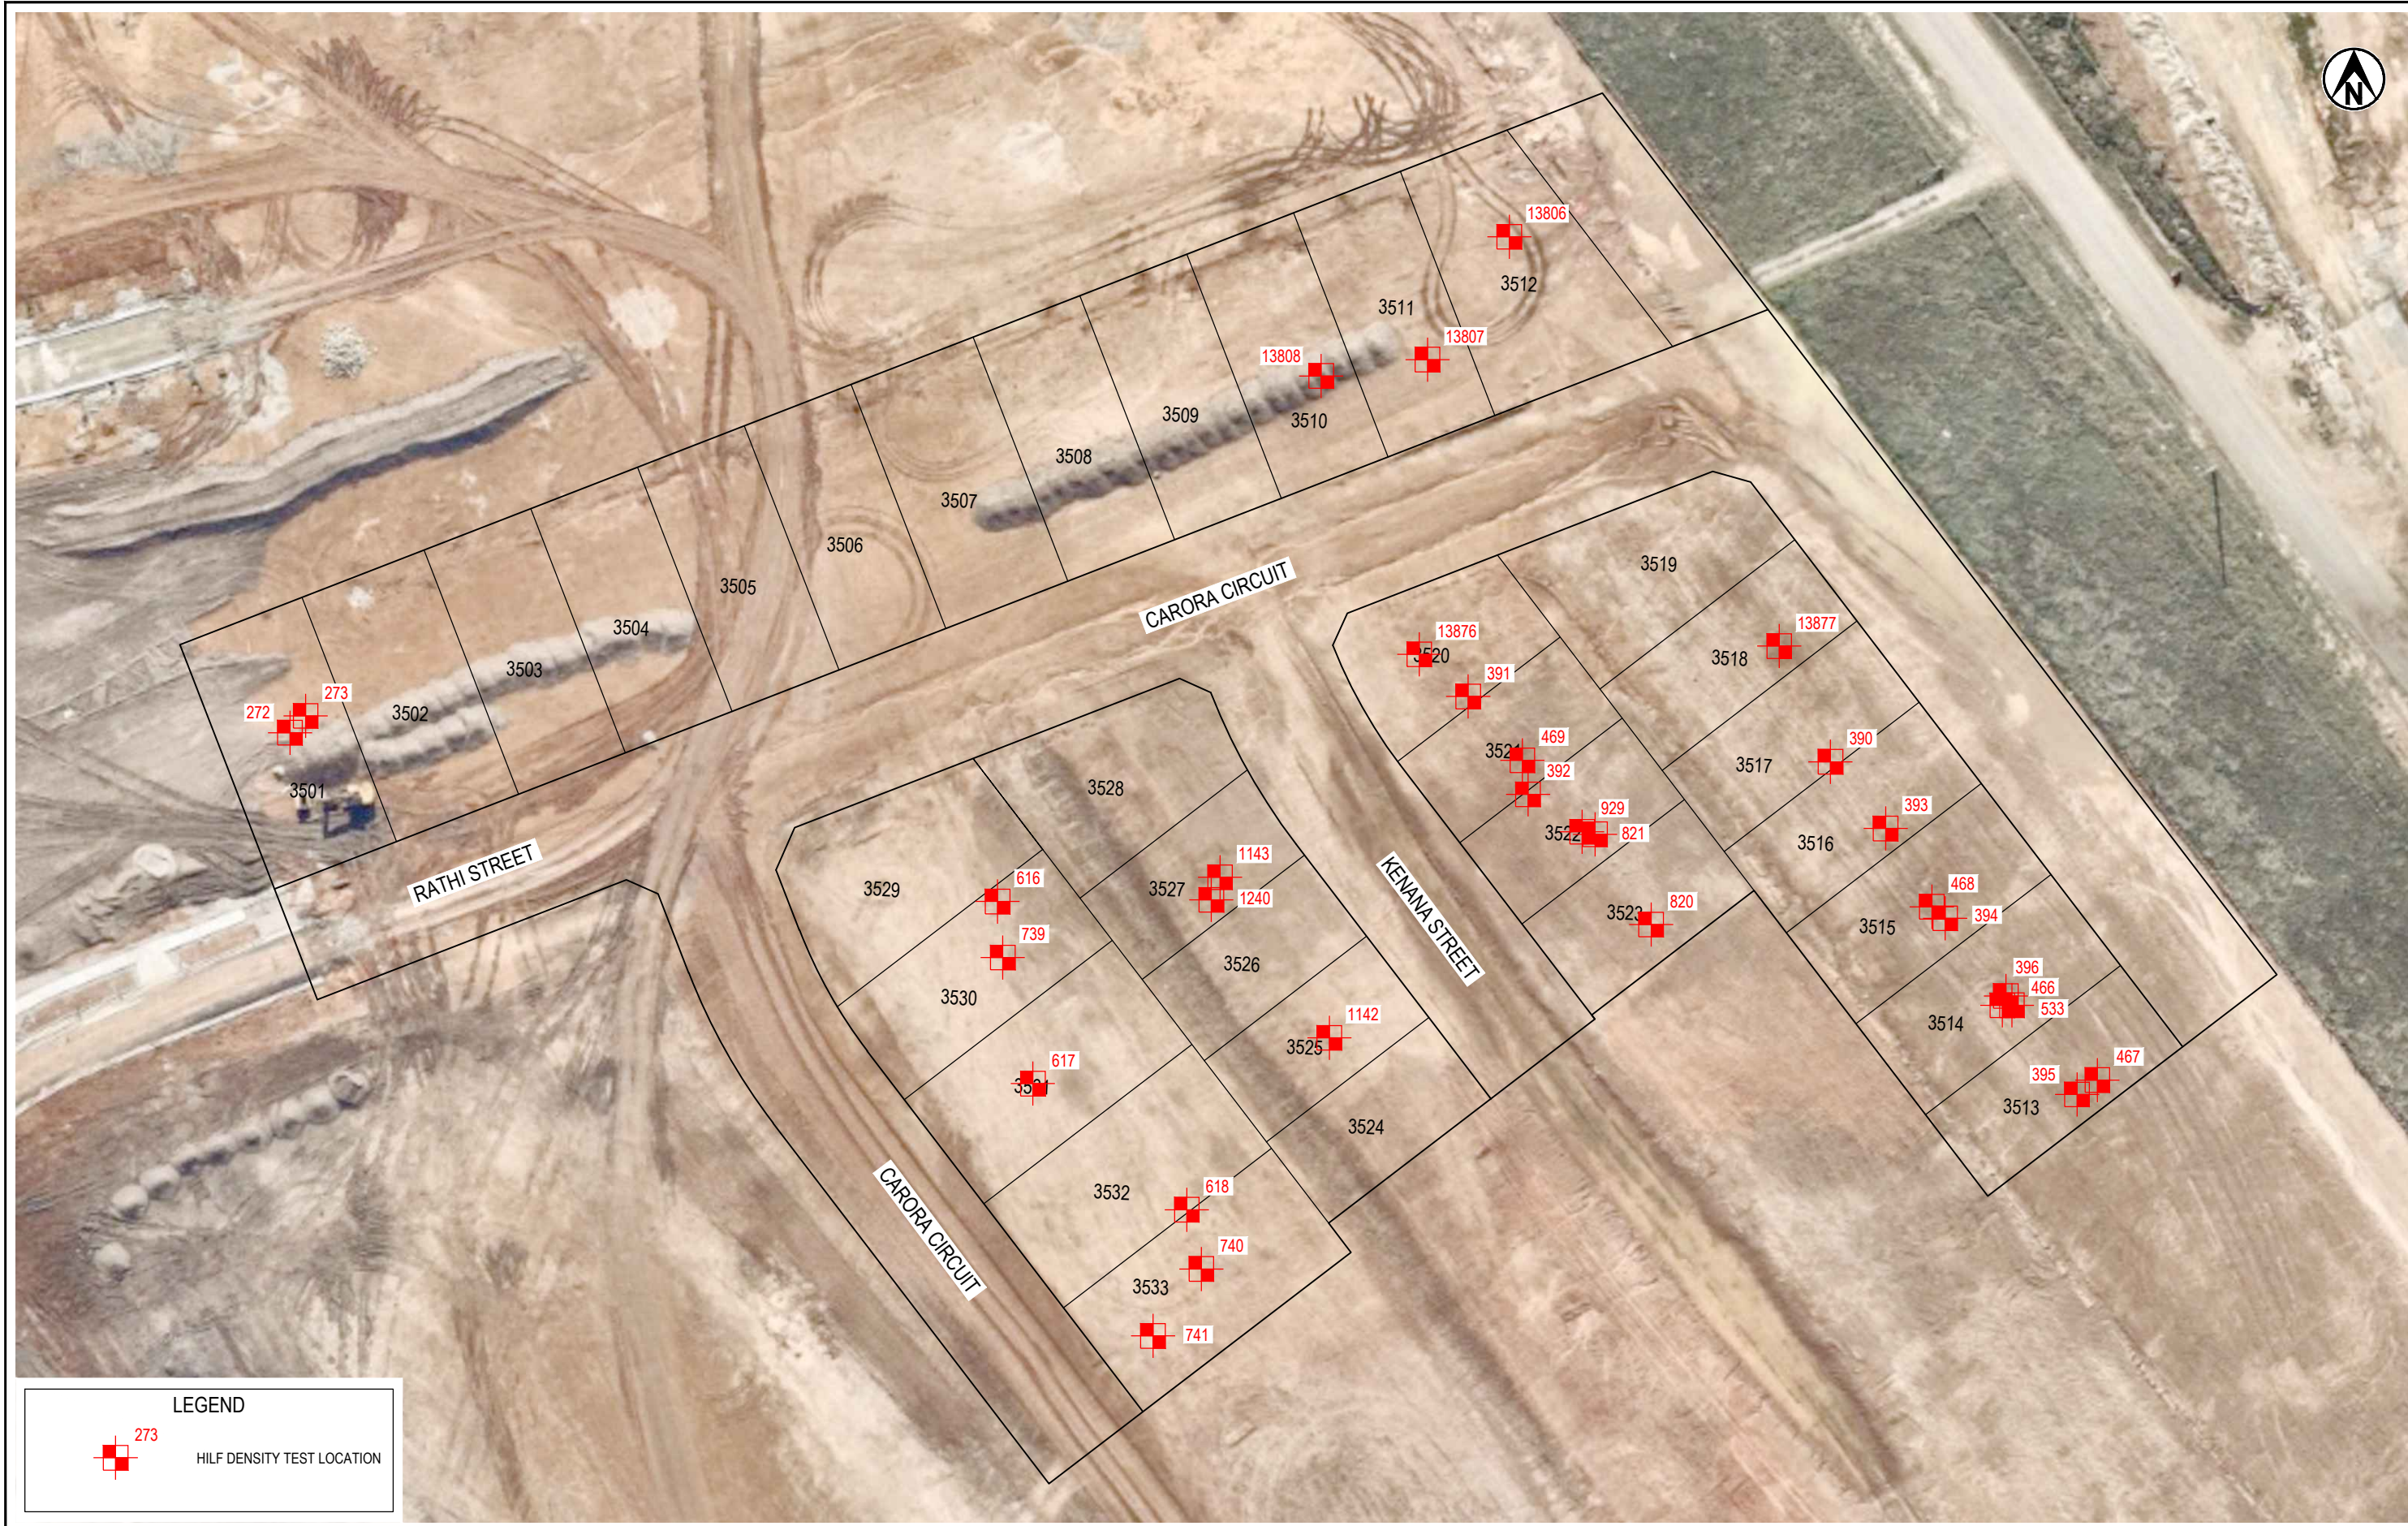
CLIENT	GROSVENOR LODGE PTY LTD	
PROJECT	MERIDIAN ESTATE - STAGE 35	
TITLE	LEVEL ONE HIF DENSITY TESTING HIF DENSITY TEST LOCATION PLAN	
SCALE (A3)	1:750	FIG No. 3807351-F01
REV	1

The results show that 6 tests failed to meet the specification requirements for the project. The earthworks contractor was advised of the tests that failed and the fill relevant to the area was reworked, reconditioned, re-compacted and subsequently retested. The results show that the tests achieved the specification requirements for the project.
