REPORT

Level One Inspection and Testing Services

Meridian Central Estate Stage 36, Clyde Lot's 3601 to 3642

Our Ref: 3807351.036.v1

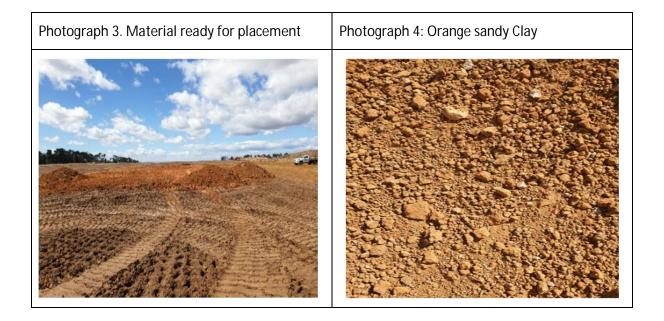
Table 5: Materials used for fill

Below are two photographs of the fill material used during construction.
