Level One Inspection and Testing Services

Meridian Estate Stage 10, Clyde North, Lots 1001 to 1075

Grosvenor Lodge Pty Ltd

Our Ref: 3807351.010 Stage 10.v1

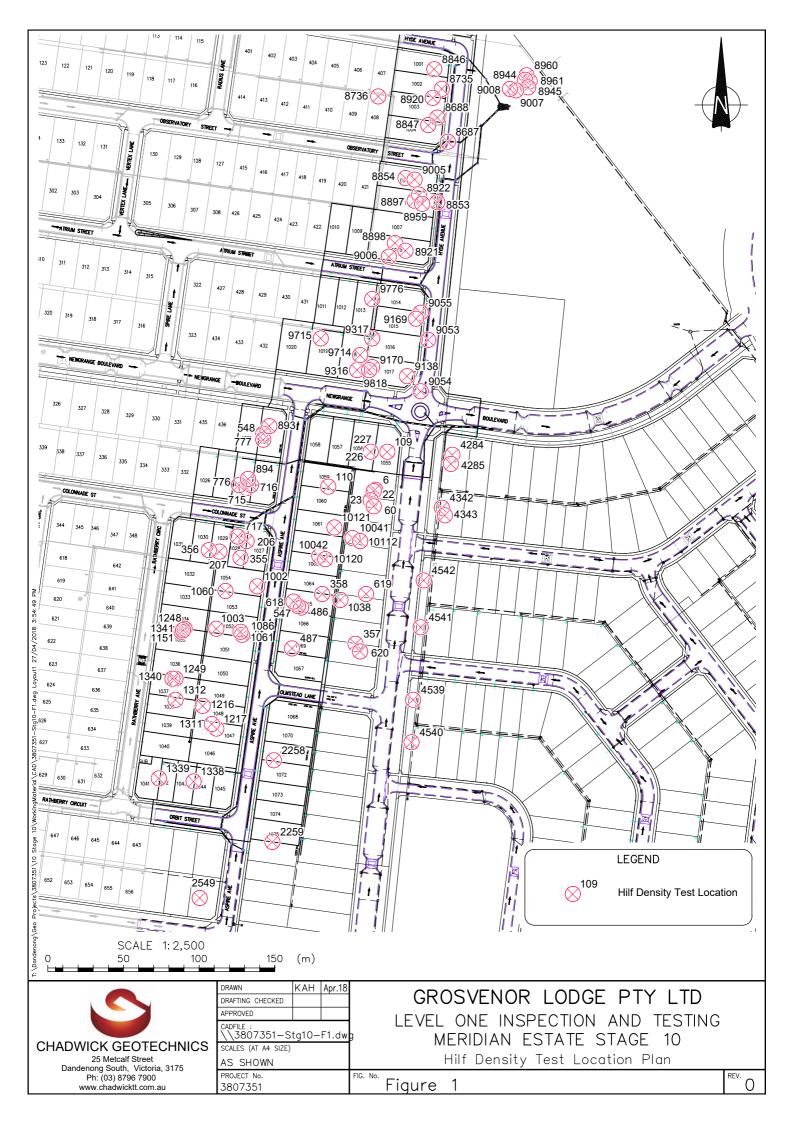
Appendix A: Density Test Location Plan

Field density and moisture content testing was carried out using a calibrated nuclear density gauge in accordance with AS 1289.5.8.1. The HILF rapid compaction test was used for peak converted wet density determinations in accordance with AS 1289.5.7.1. Test locations were recorded using a handheld GPS unit. A site plan showing the field density test locations is provided in Appendix A.
