REPORT

Level One Inspection and Testing Services

**Meridian Estate Stage 5, Clyde North
Lot's 537 to 546**

Our Ref: 3807351.005.v1

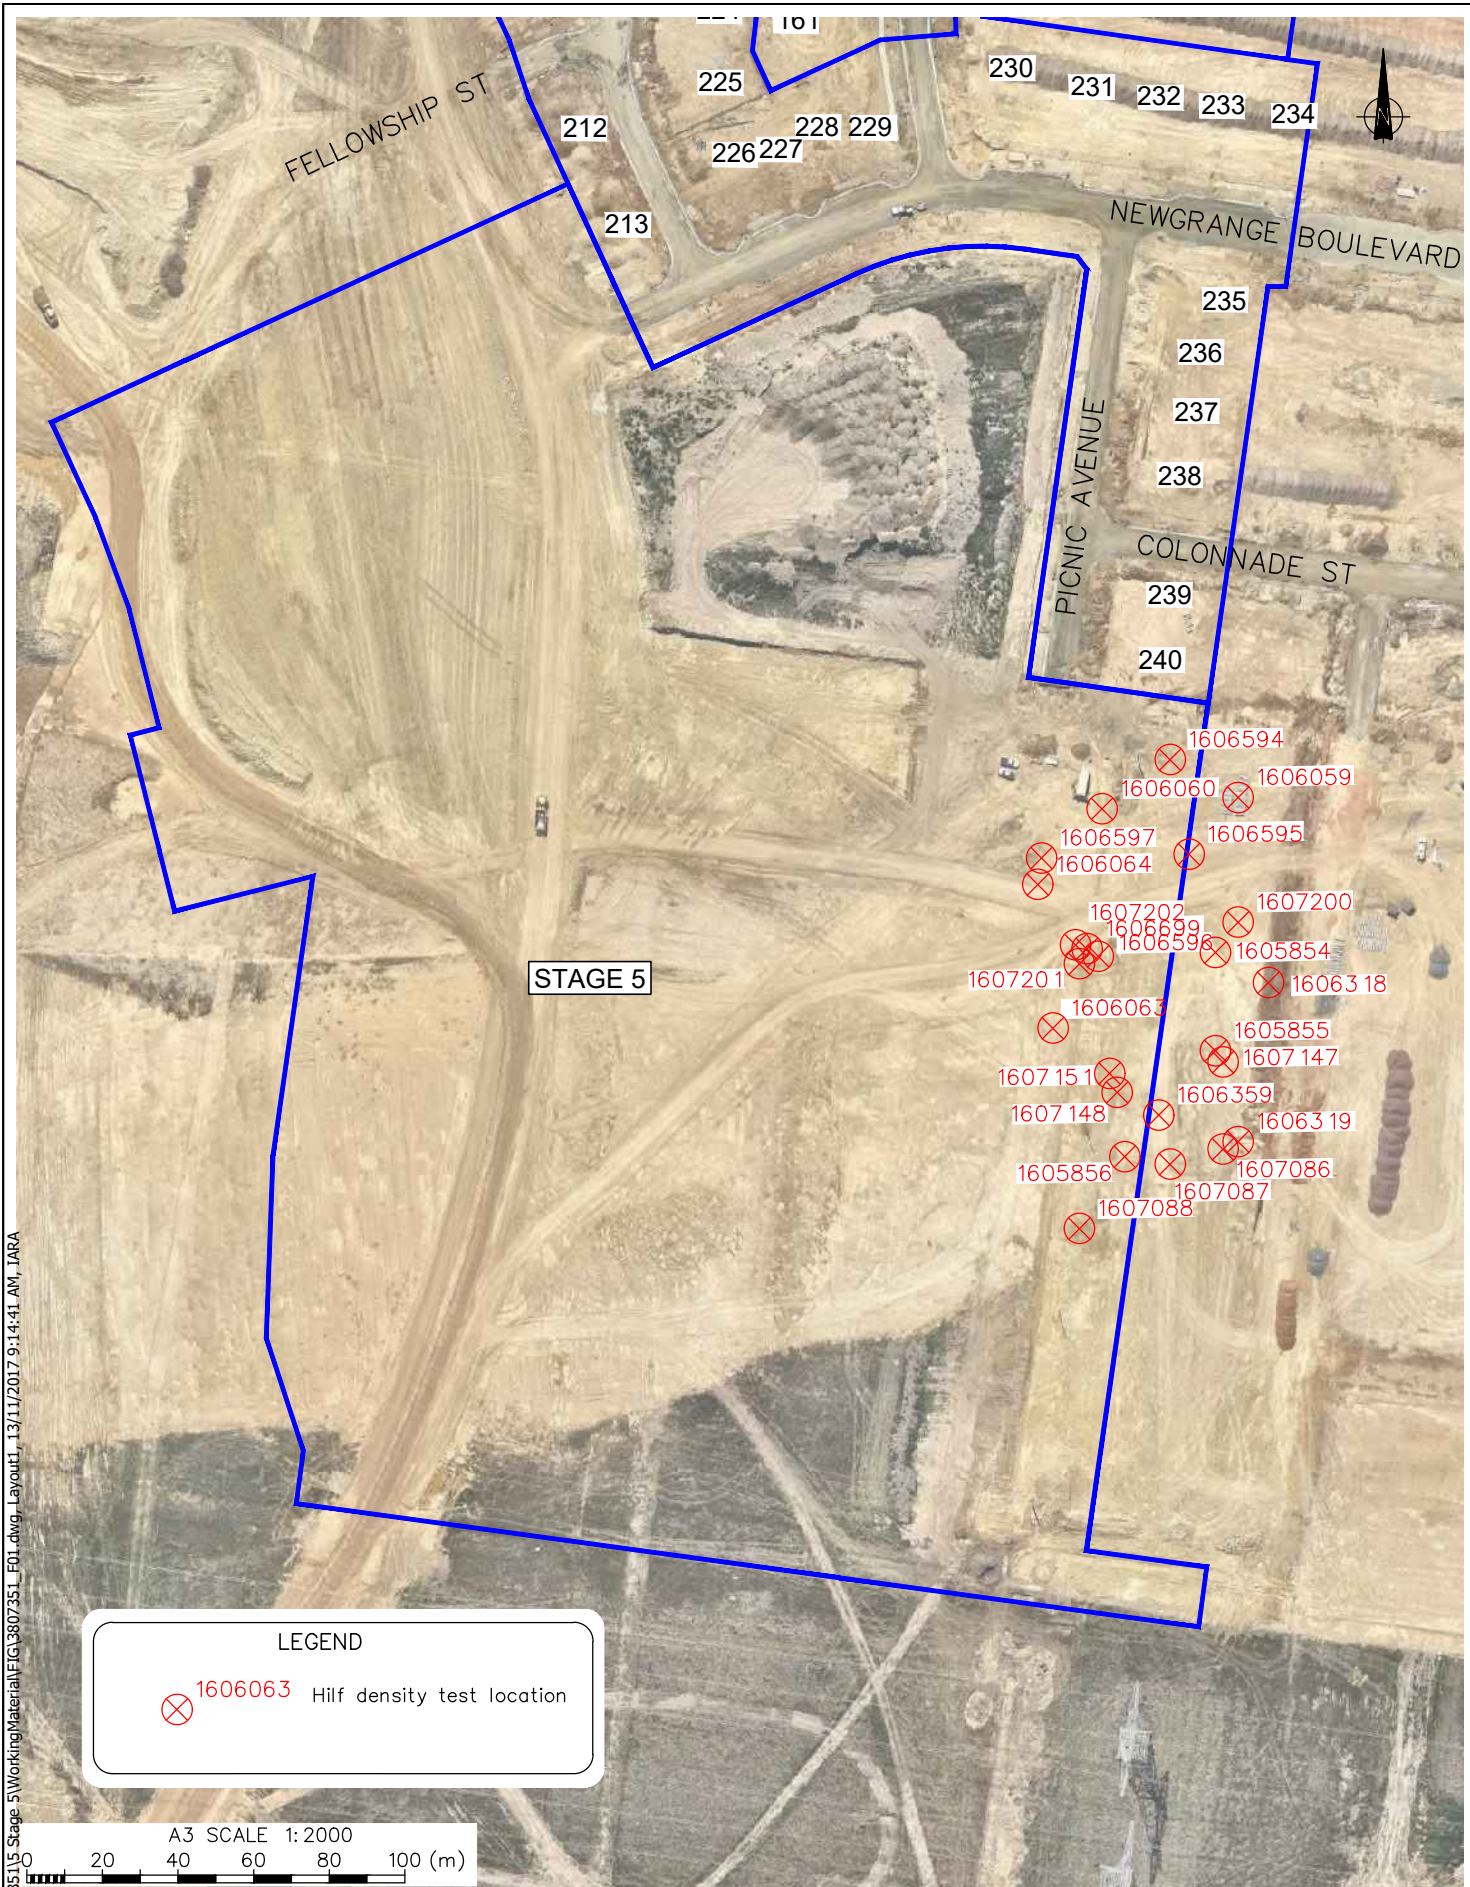
GREENBRIDGE PROPERTIES PTY LTD
 LEVEL 1 INSPECTION AND TESTING
 MERIDIAN ESTATE – STAGE 5
 Level 1 Hilf Test Location Plan

Field density and moisture content testing was carried out using a calibrated nuclear density gauge in accordance with AS 1289.5.8.1³. The HILF rapid compaction test was used for peak converted wet density determinations in accordance with AS 1289.5.7.1. The test locations were recorded using a handheld GPS unit. A site plan showing the field density and moisture content test locations is provided in **Appendix A**.
