## **Level 1 Geotechnical Testing and Inspection Authority Services**

**Meridian Central Estate Stage 39  
Clyde North  
Lots 3901 to 3929 & 3935 to 3939**

**Grosvenor Lodge Pty Ltd.**

**Our Ref: 3807351.039.v1**

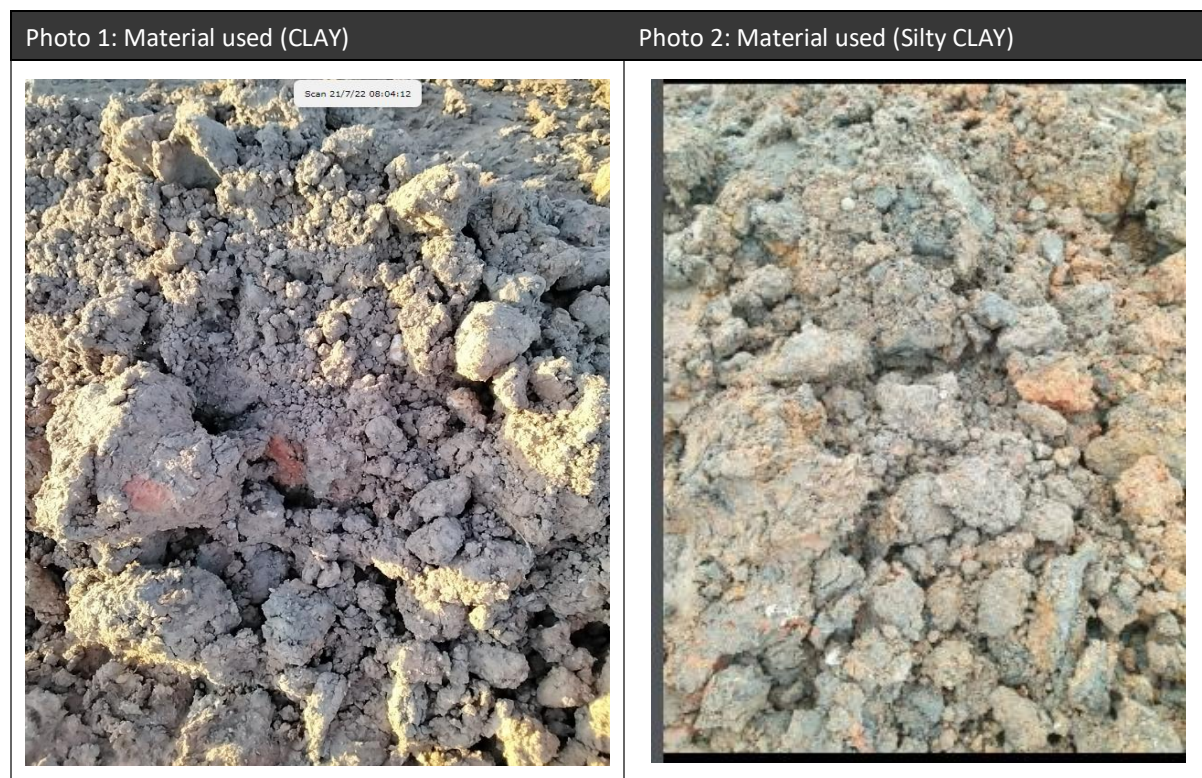
*Figure 3.1: Photographs of the material used on site*

The laboratory test results indicated material is silty /sandy clay of medium to high plasticity.

The material was deemed as being derived from natural soils. The soil is considered as 'Suitable Material' in accordance with Section 4.4 of the AS3798-2007.

Below are two photographs of typical materials used during construction.

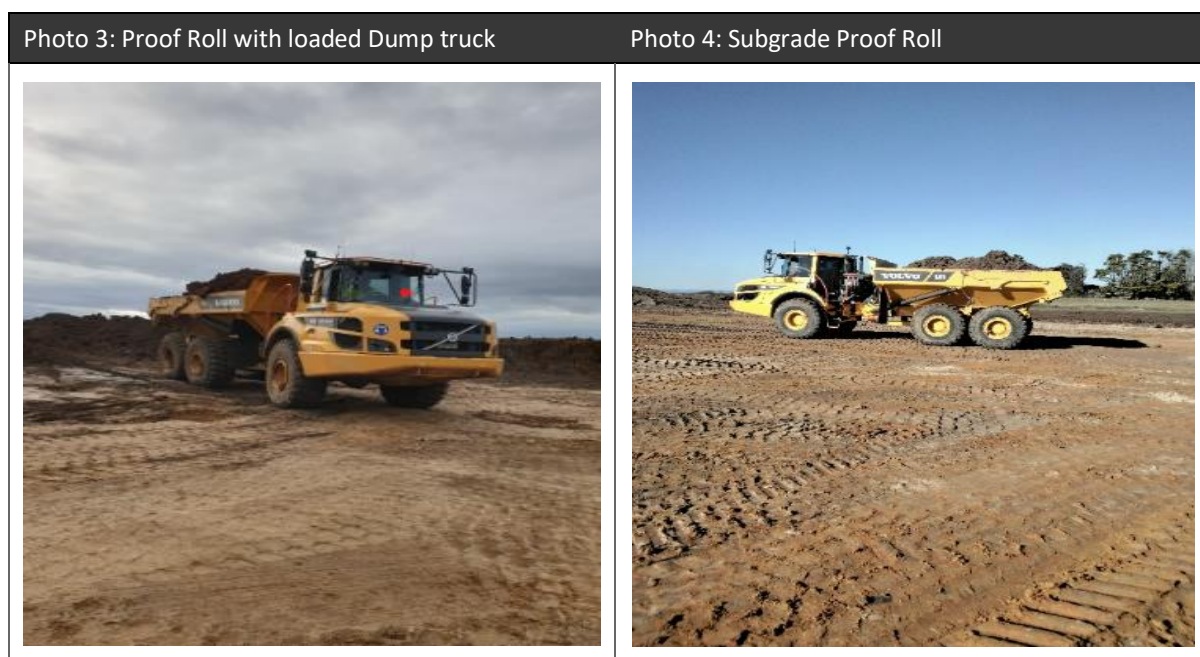
*Figure 3.2: Subgrade assessment photographs*

The subgrade inspections were performed in accordance with the Level 1 guidelines presented in AS 3798–2007 Section 5.5. No soft spots or deflections were encountered during the inspections and the area was found to be firm and free of vegetation and other deleterious material.

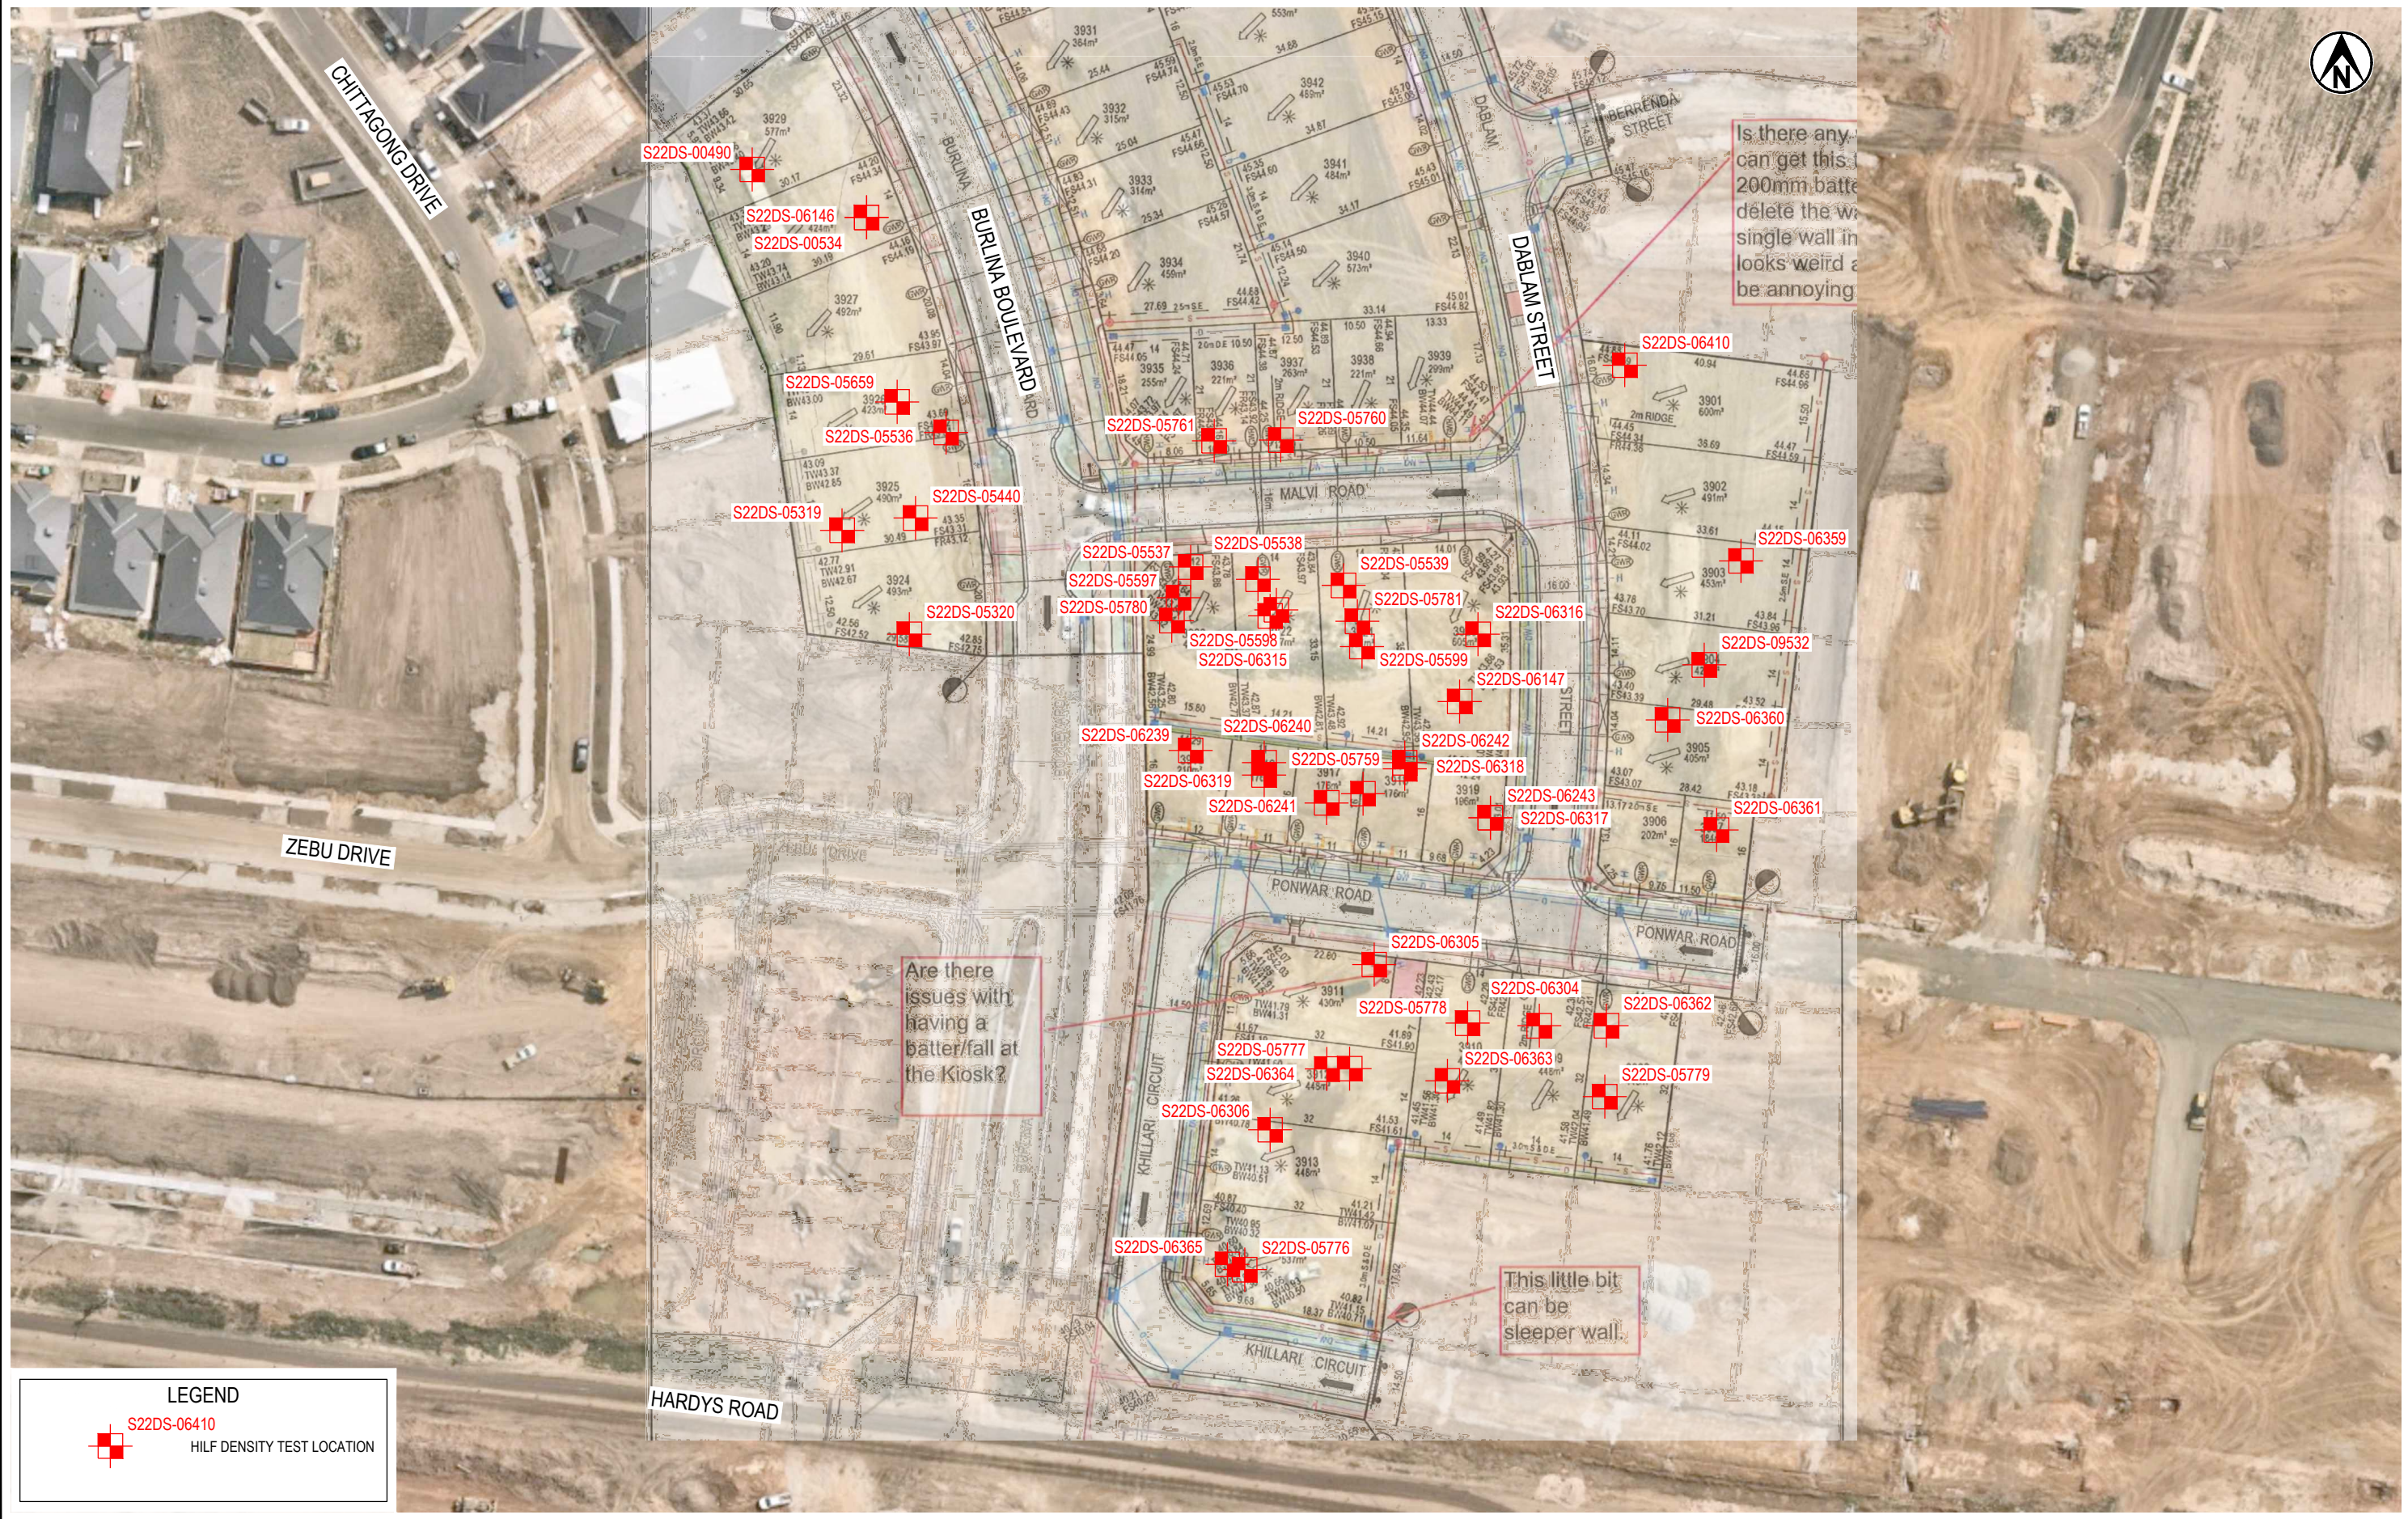
Forty-Seven (47) tests were performed during the filling process. Two (2) of the tests did not achieve the required density and or moisture ratio initially. The failed area was reworked and retested accordingly. The retests returned passing density and moisture test results.
