Level 1 Geotechnical Testing and Inspection Authority Services

**Meridian Central Estate Stage 40
Clyde North
Lots 4001 to 4028**

Grosvenor Lodge Pty Ltd.

4 May 2023

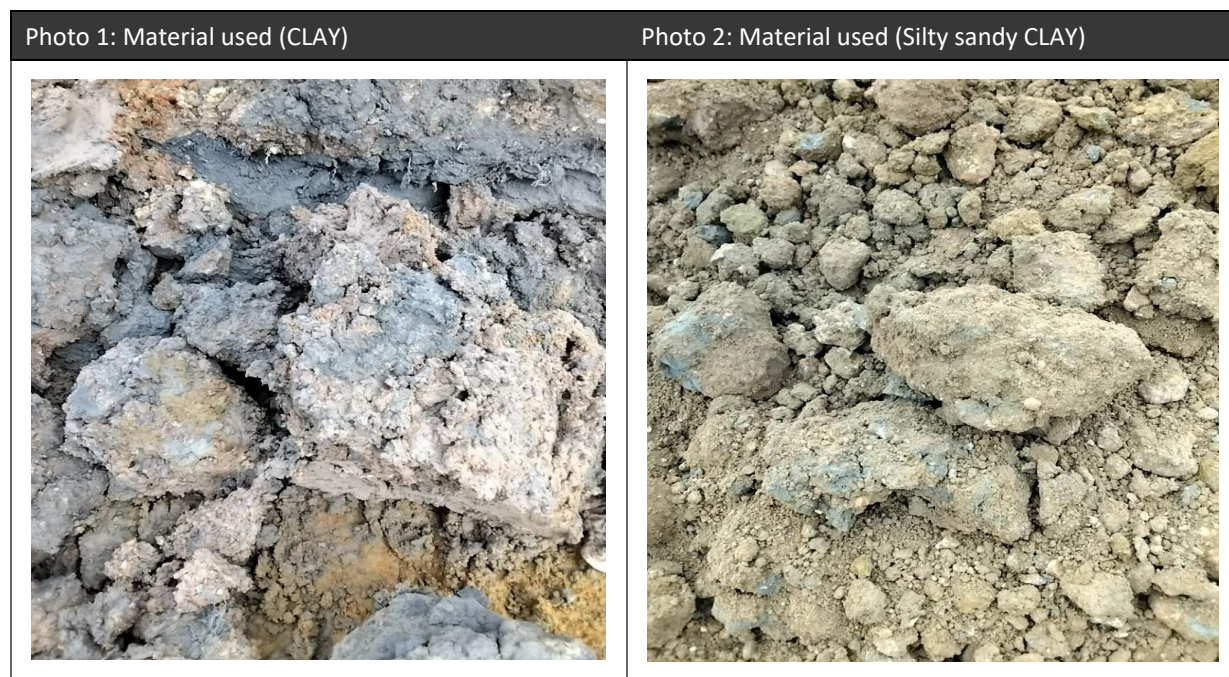
Figure 3.1: Photographs of the material used on site

The laboratory test results indicated material is silty /sandy clay of medium to high plasticity.

The material was deemed as being derived from natural soils. The soil is considered as 'Suitable Material' in accordance with Section 4.4 of the AS3798-2007.

Any observed organic or deleterious matter including any oversize cobbles or boulders were removed from the tested areas during the fill placement.

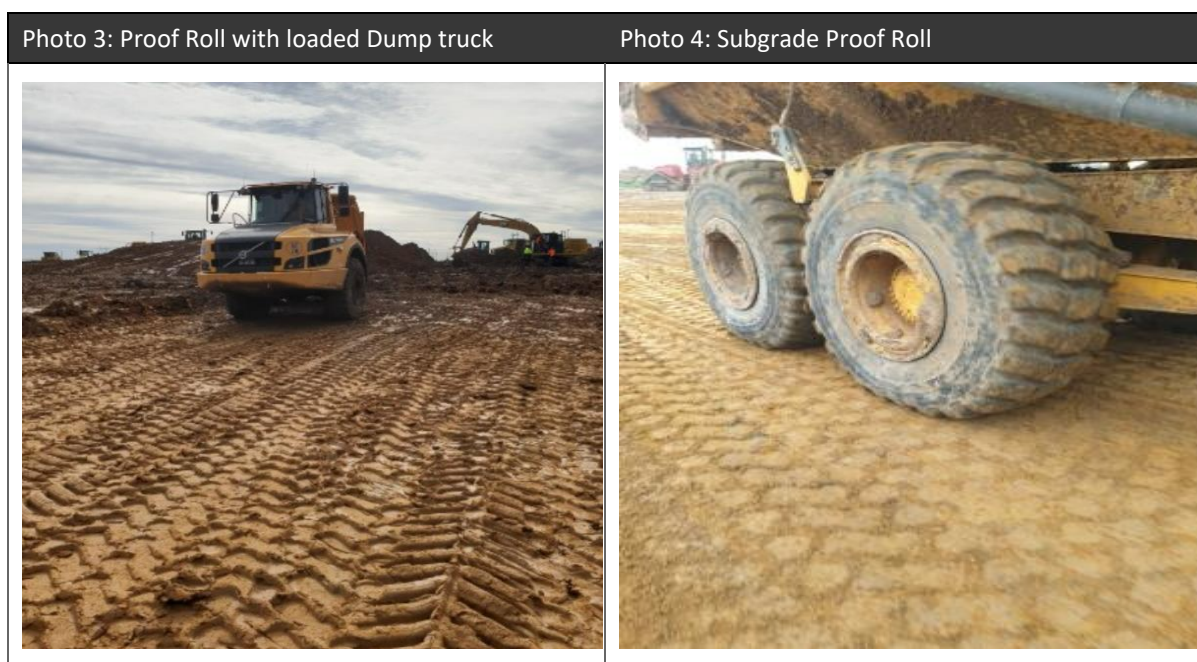
Figure 3.2: Subgrade assessment photographs

The subgrade inspections were performed in accordance with the Level 1 guidelines presented in AS 3798–2007 Section 5.5. No soft spots or deflections were encountered during the inspections and the area was found to be firm and free of vegetation and other deleterious material.

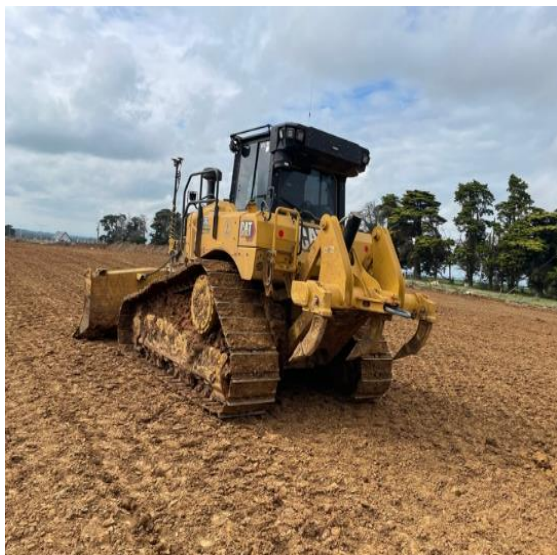
Photo 5: Dozer used on site

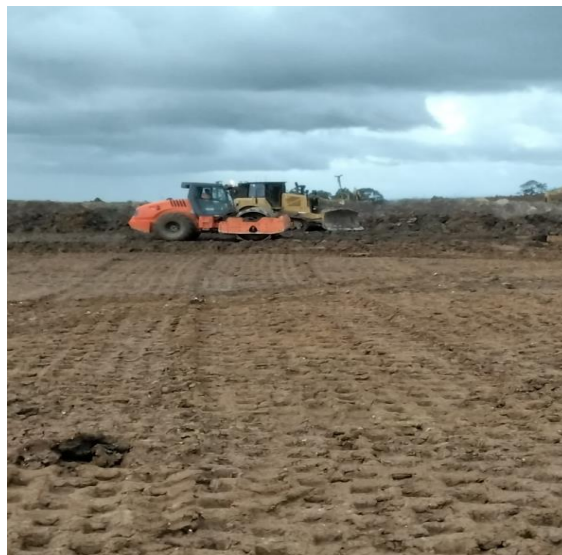
Photo 6: Pad foot used on compaction

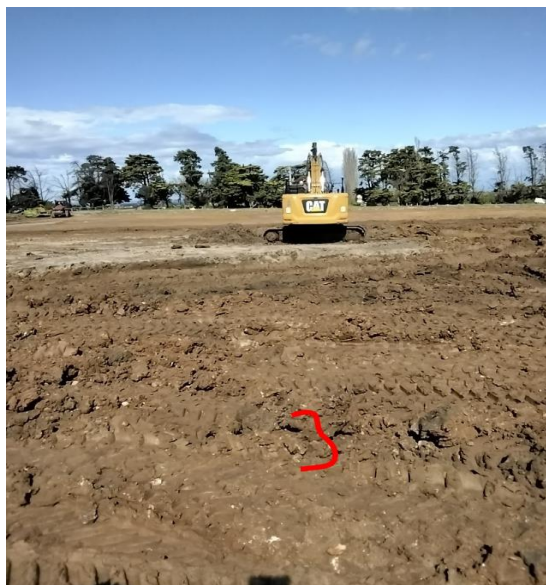
Photo 7: CAT Excavator

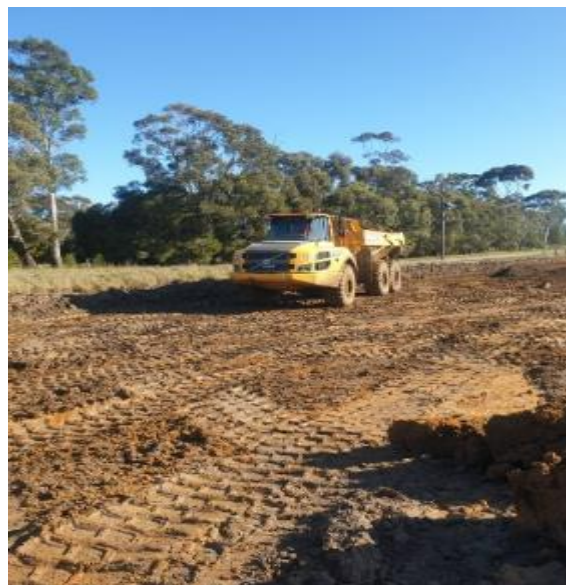
Photo 8: Dump truck

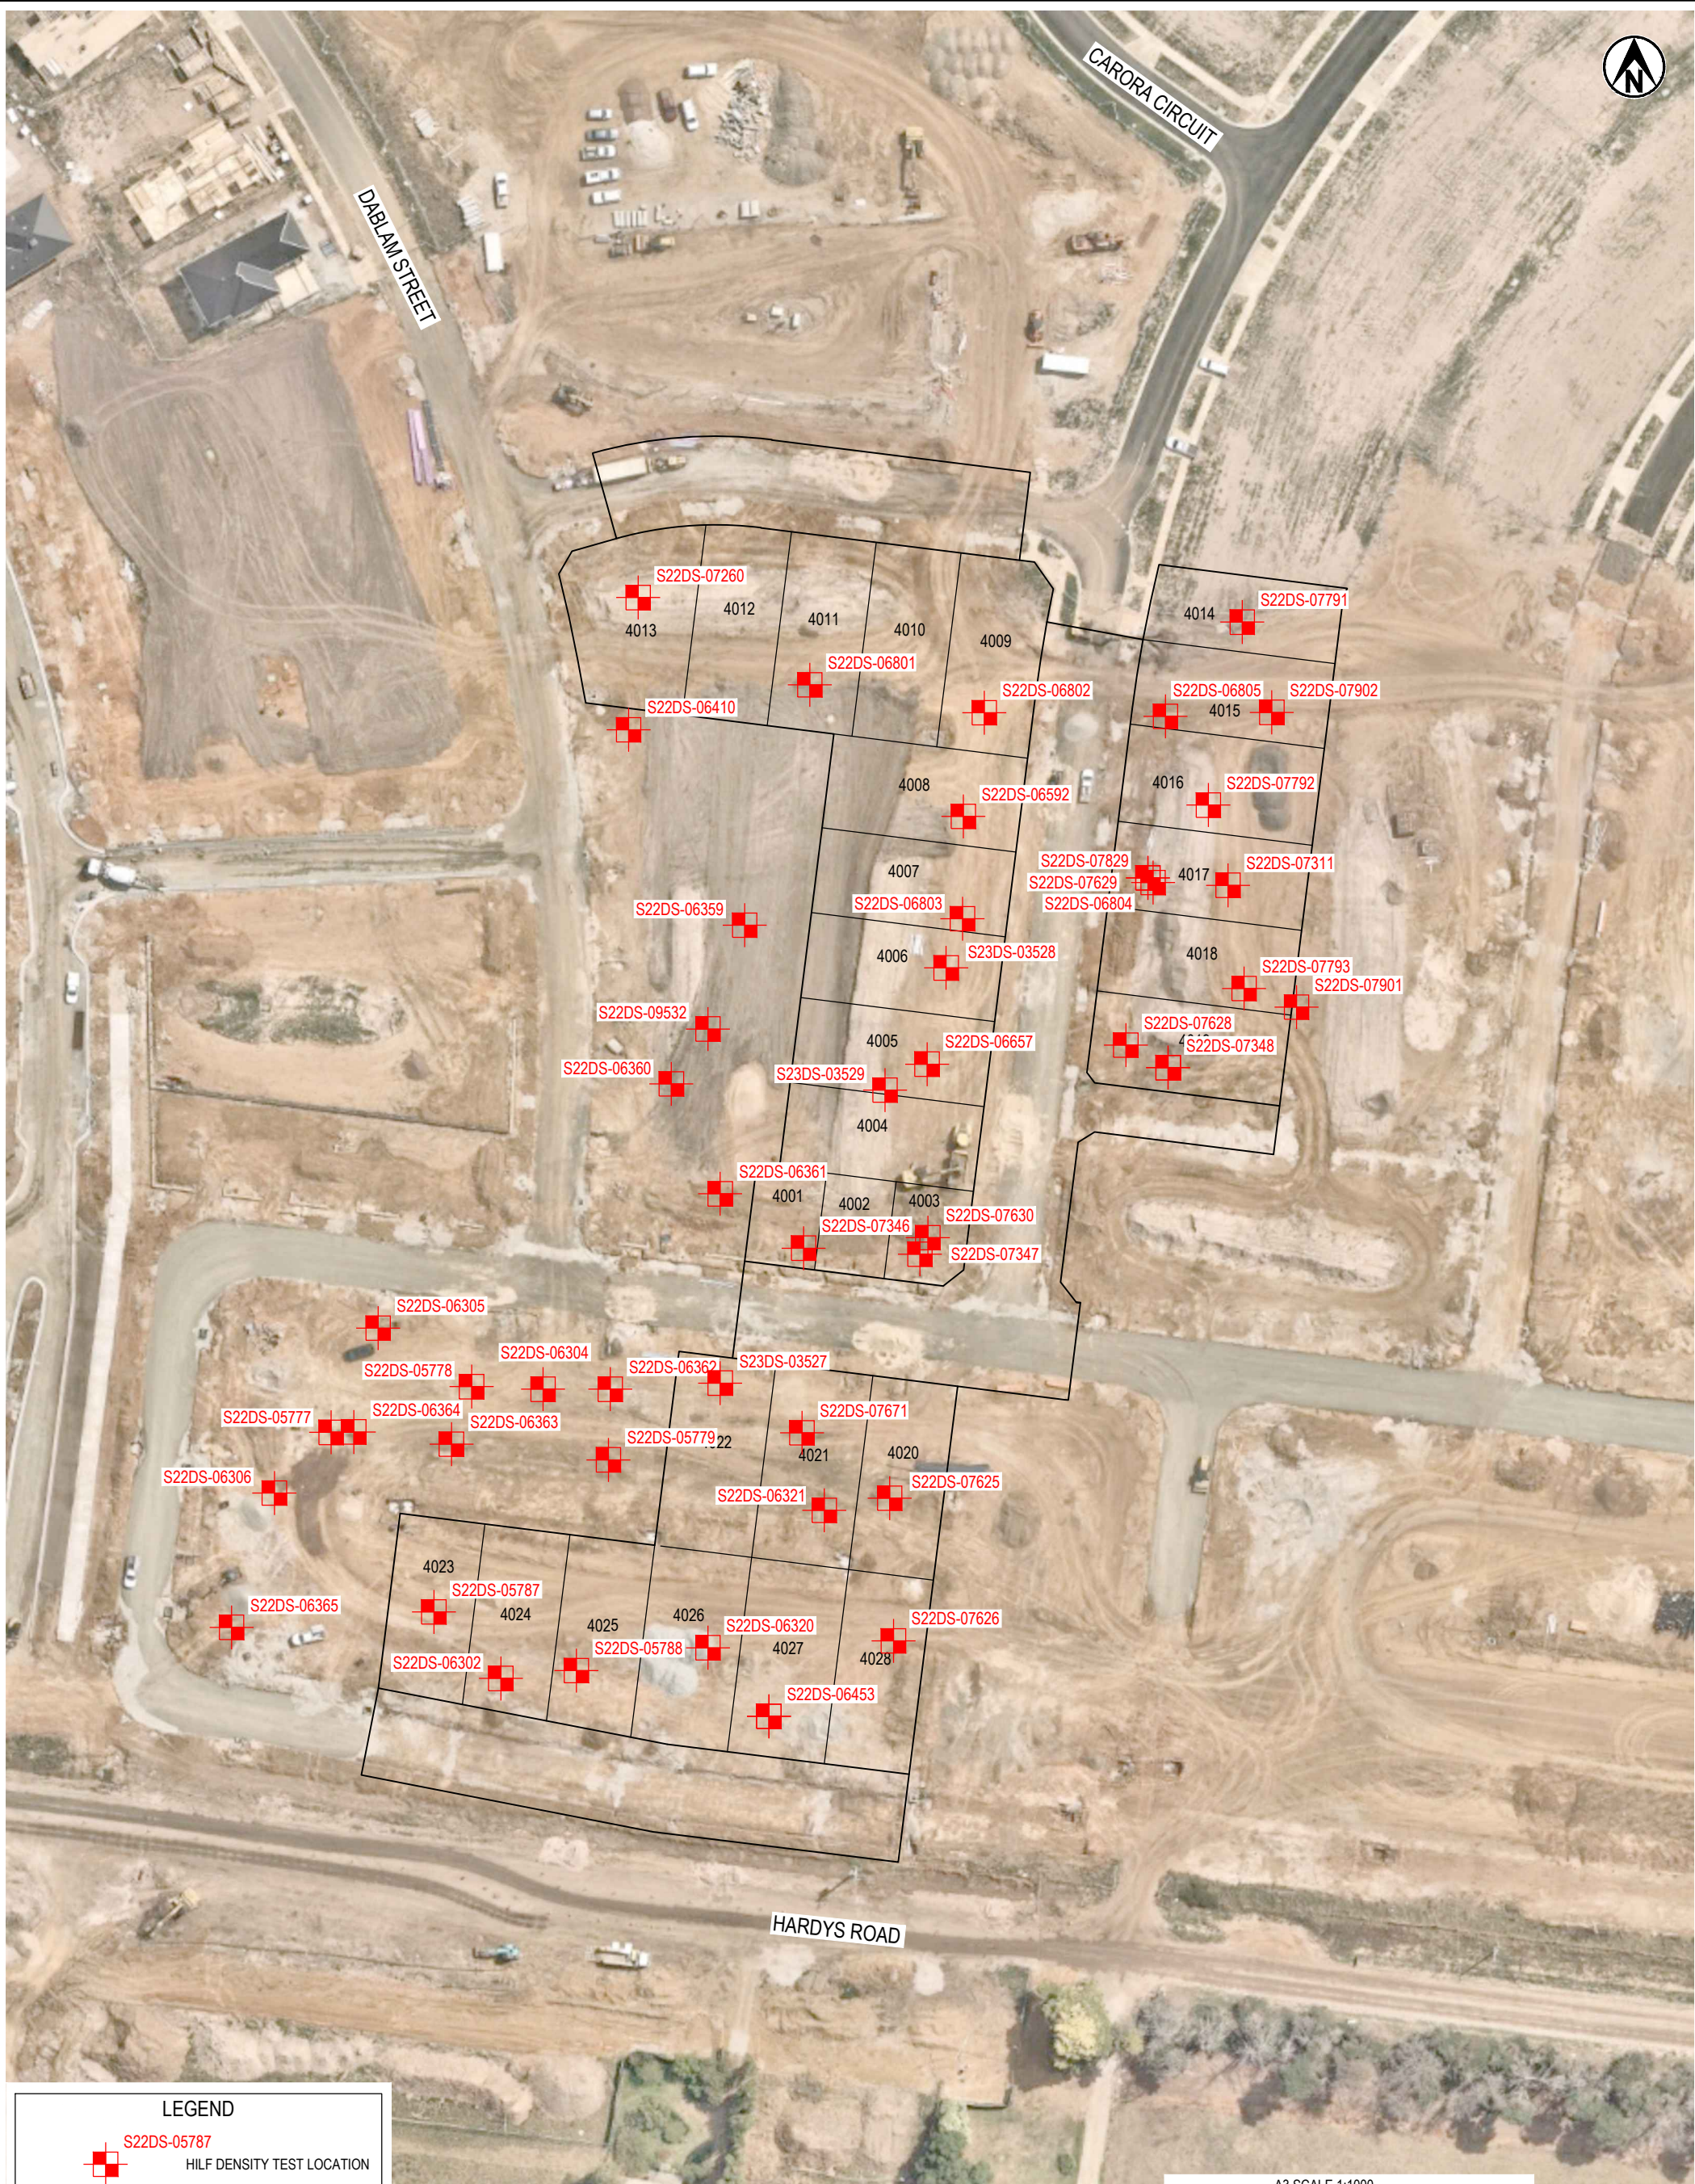
Appendix A : Location Plan

S22DS-05787
HILF DENSITY TEST LOCATION
