Level 1 Geotechnical Testing and Inspection Authority Services

**Meridian Central Estate Stage 41
Clyde North
Lots 4101 to 4135**

Grosvenor Lodge Pty Ltd.

Our Ref: 3807351.041.v1

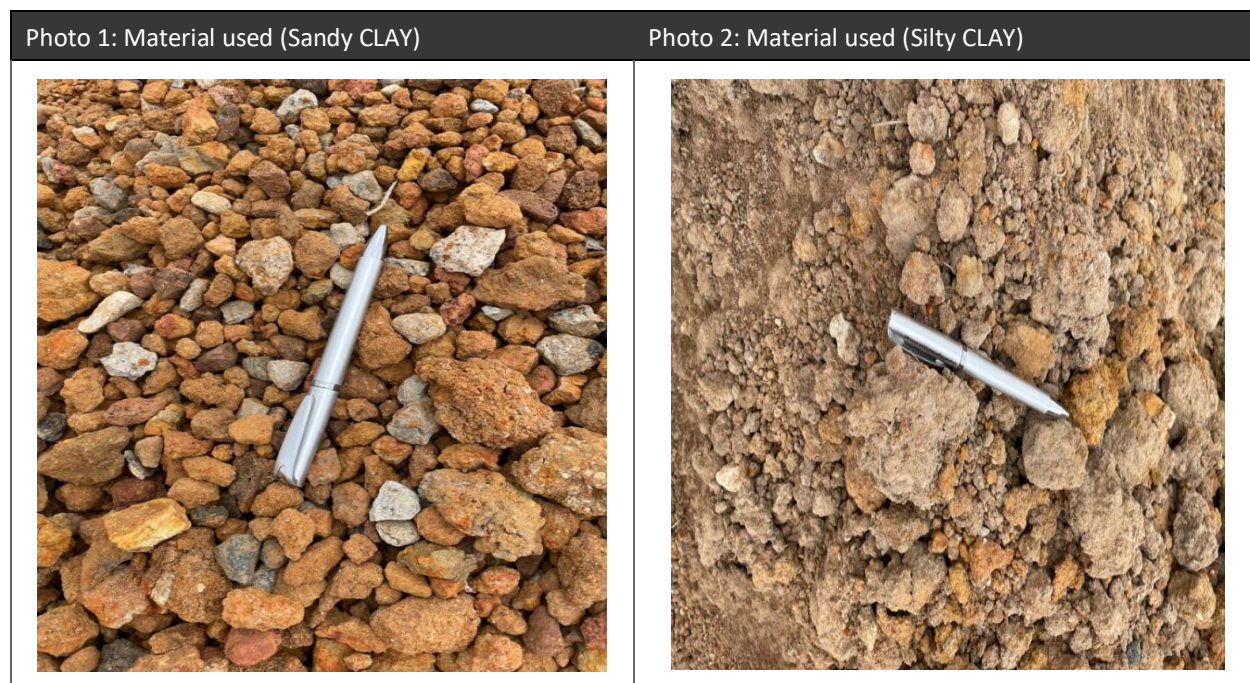
Figure 3.1: Photographs of the material used on site

The laboratory test results indicated material is silty /sandy clay of medium to high plasticity.

The material was deemed as being derived from natural soils. The soil is considered as 'Suitable Material' in accordance with Section 4.4 of the AS3798-2007.

Any observed organic or deleterious matter including any oversize cobbles or boulders were removed from the tested areas during the fill placement.

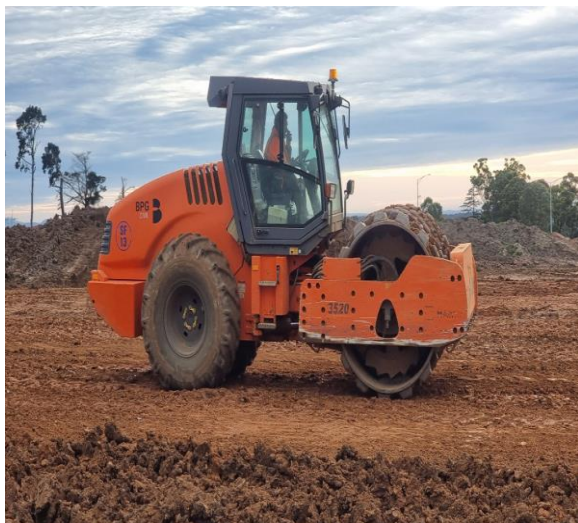
The subgrade inspections were performed in accordance with the Level 1 guidelines presented in AS 3798–2007 Section 5.5. No soft spots or deflections were encountered during the inspections and the area was found to be firm and free of vegetation and other deleterious material.

Photo 3: Proof Roll with Pad foot roller

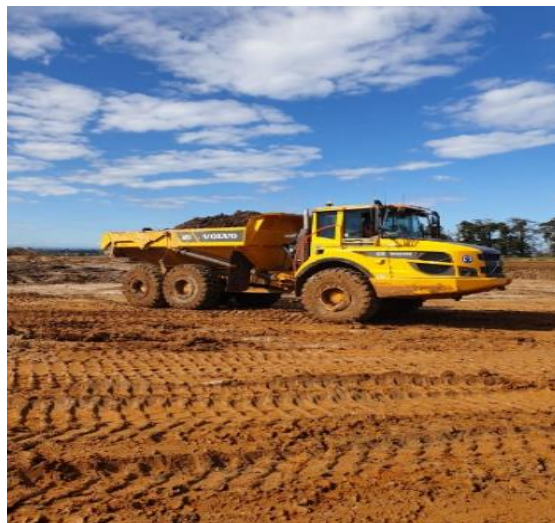
Photo 4: Subgrade Proof Roll with dump truck
