Level 1 Geotechnical Testing and Inspection Authority Services

**Meridian Green Estate Clyde North
Stage 48**

Lots 4801, 4802, 4809 to 4817, 4823 to 4844

Our Ref: 1091936.048.v1

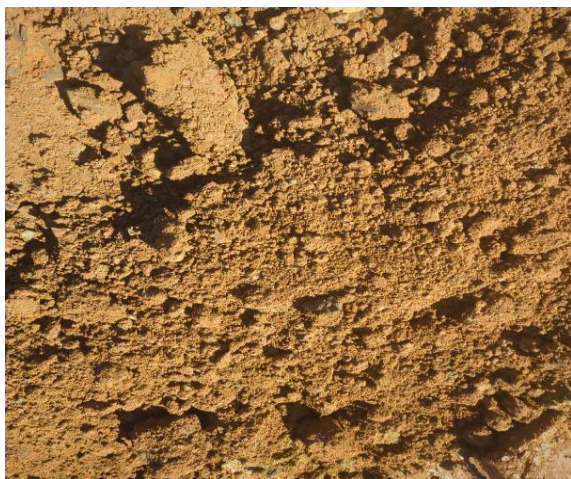
Photograph 1: Typical on-site clay material

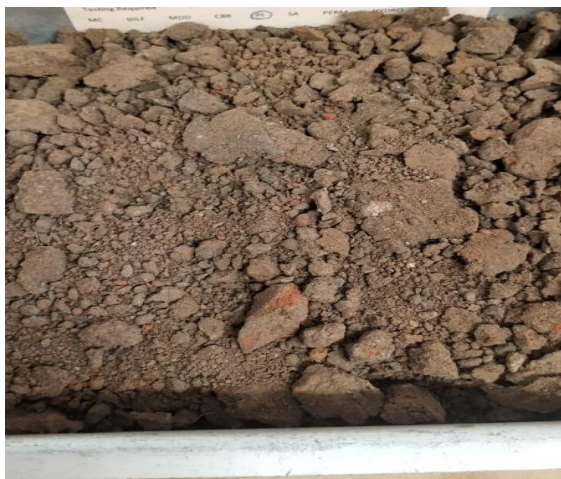
Photograph 2: Silty Brown Clay

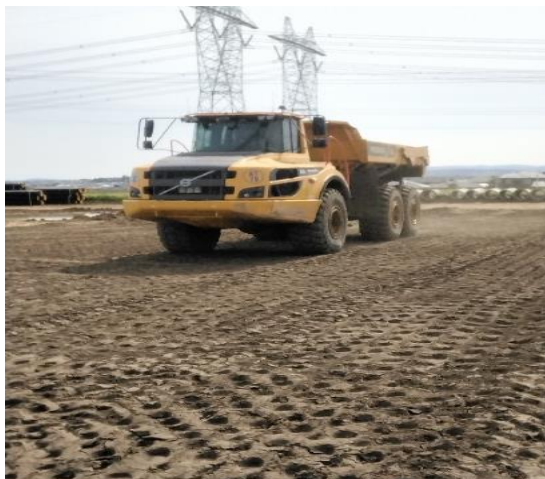
The subgrade inspections were performed in accordance with the Level 1 guidelines presented in AS 3798–2007 Section 5.5. No soft spots or deflections were encountered during the inspections and the area was found to be firm and free of vegetation and other deleterious material.

Photograph 3: Proof Roll with Dump Truck

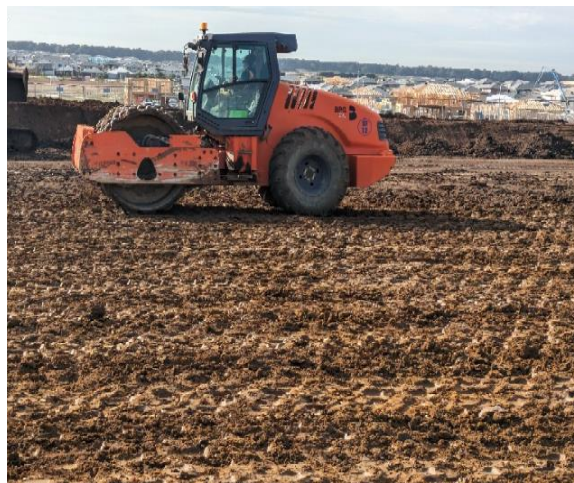
Photograph 4: Subgrade assessment with 15 Tonne Pad foot Roller

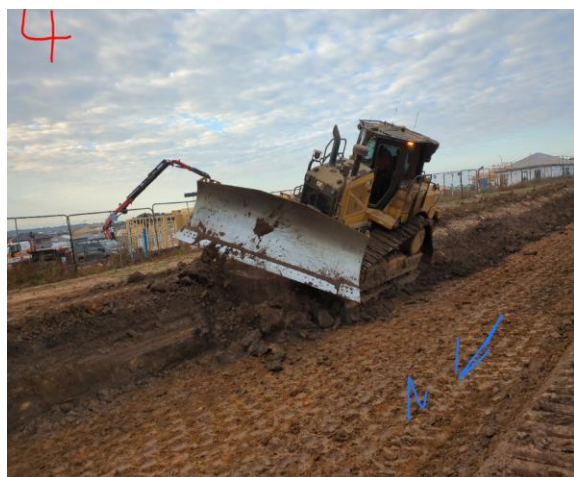
*Photograph 5: D6 Dozer used during filling.*

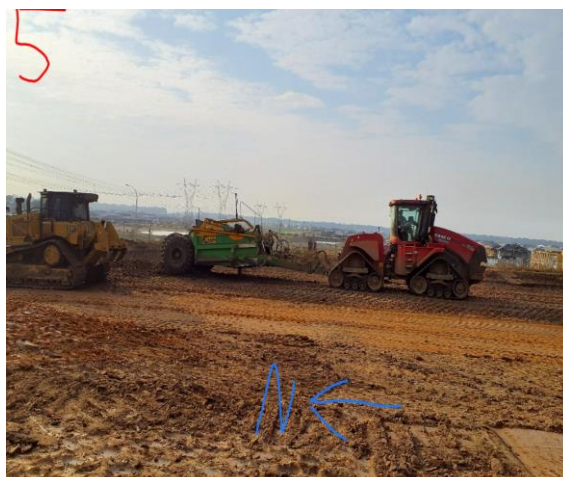
*Photograph 6: Scraper moving clay*

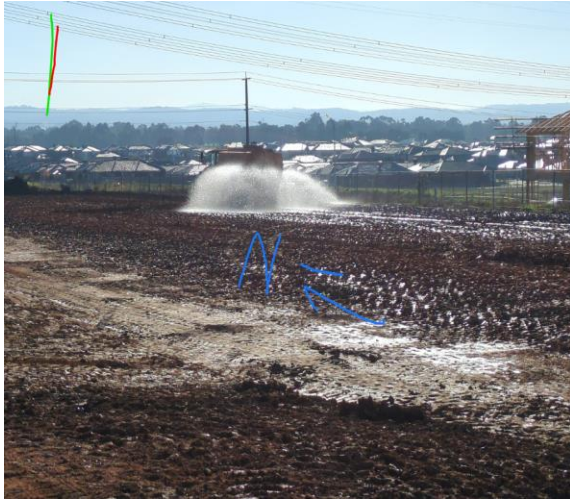
Photograph 7: Water cart used for moisture conditioning

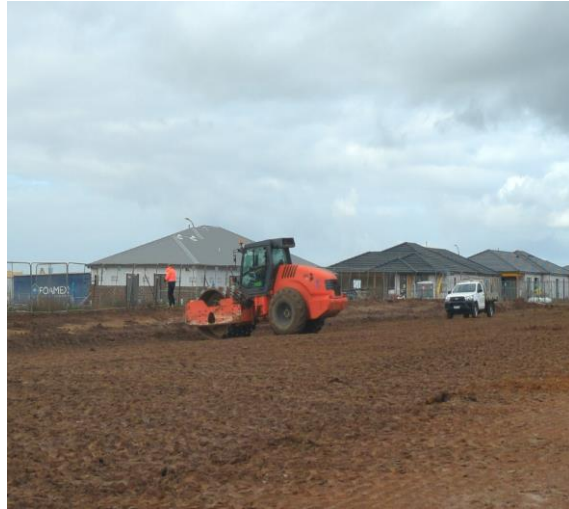
Photograph 8: Pad foot compacting fill material

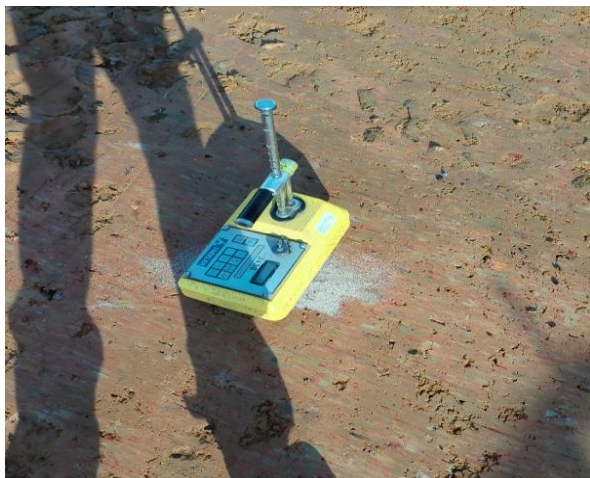
Photo 9: Field density/moisture test

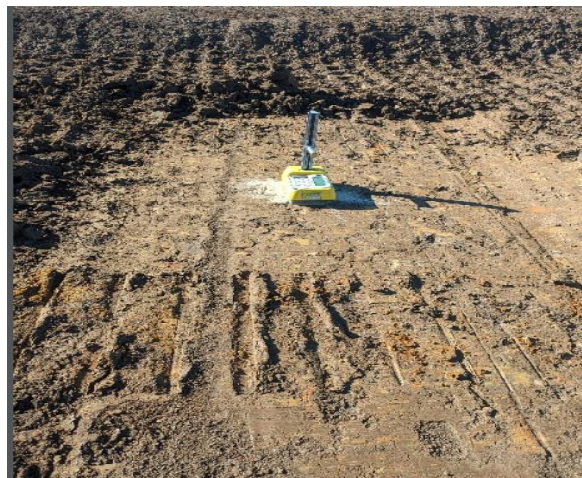
Photo 10: Field density/moisture test
