Level 1 Geotechnical Inspection and Testing Authority Services

**Meridian Green Estate Clyde North
Stage 50A Lots 5011 to 5029**

Our Ref: 1091936.050A.v1

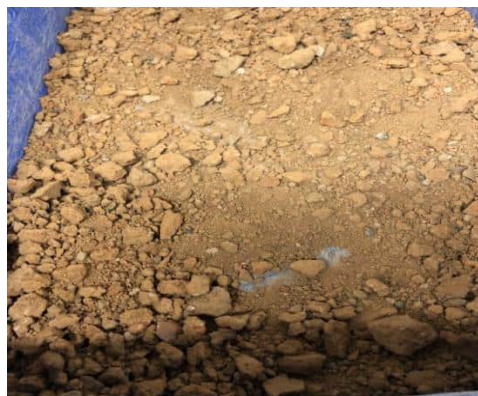
Photograph 2: Silty Mottled Orange Brown Clay

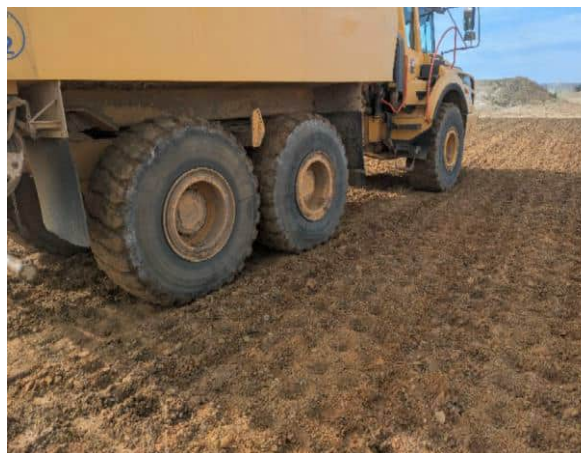
The subgrade inspections were performed in accordance with the Level 1 guidelines presented in AS3798–2007 Section 5.5. No soft spots or deflections were encountered during the inspections and the area was found to be firm and free of vegetation and other deleterious material.

Photograph 4: Subgrade assessment with a loaded water cart

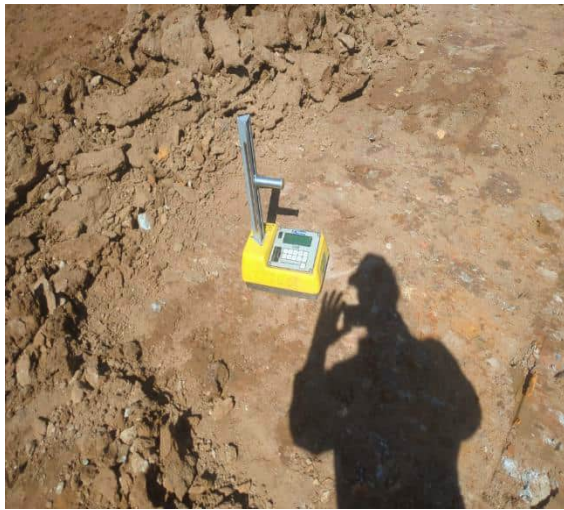
Thirty-seven (37) tests were performed during the filling process. Nine (9) of the tests did not achieve the recommended density or moisture ratio initially. The failed areas were reworked and retested accordingly. The retests returned passing density and moisture test results.

Photo 9: Field density/moisture test

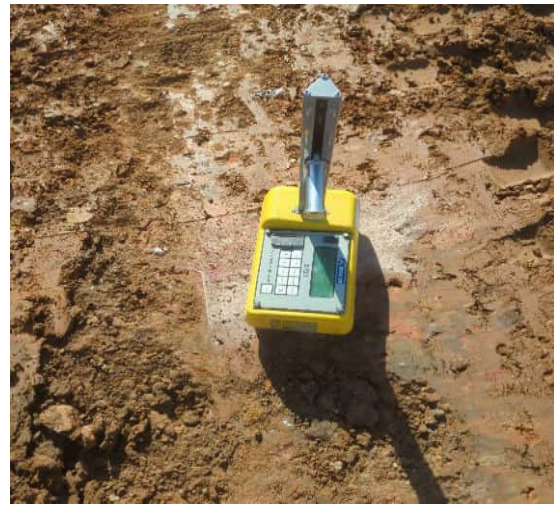
Photo 10: Field density/moisture test
