# **REPORT**

## **Level 1 Geotechnical Inspection and Testing Authority Services**

**Meridian Green Estate Clyde North  
Stage 50B Lots 5043 to 5073**

**Our Ref: 1091936.050B.v1**

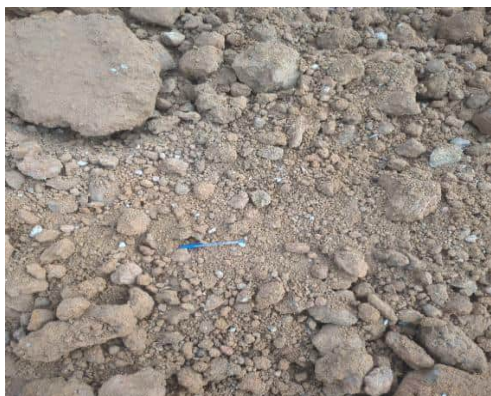
*Photograph 1: Typical on-site clay material*

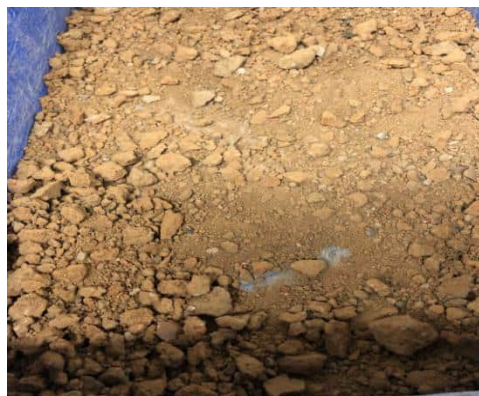
*Photograph 2: Silty Mottled Orange Brown Clay*

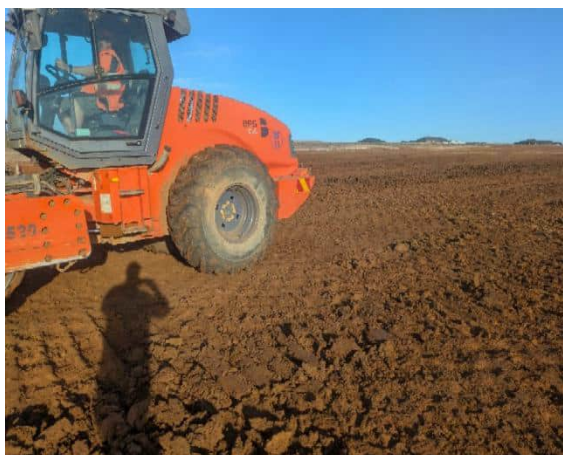
The subgrade inspections were performed in accordance with the Level 1 guidelines presented in AS3798–2007 Section 5.5. No soft spots or deflections were encountered during the inspections and the area was found to be firm and free of vegetation and other deleterious material.

*Photograph 3: Subgrade preparation with Pad foot roller*

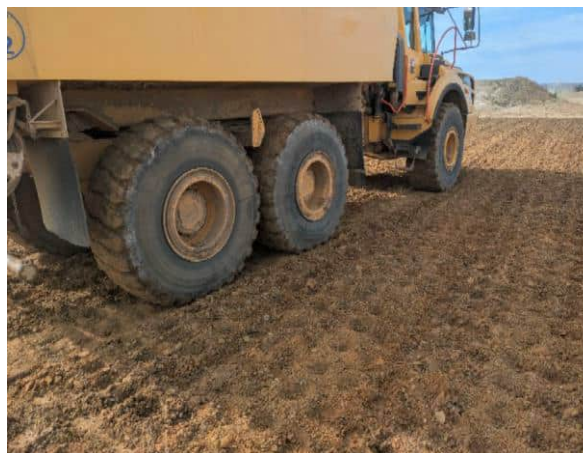
*Photograph 4: Subgrade assessment with a loaded water cart*

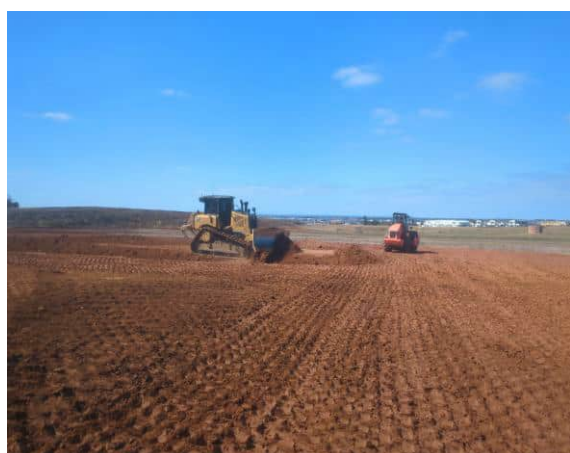
*Photograph 5: Pad foot Roller compacting.*

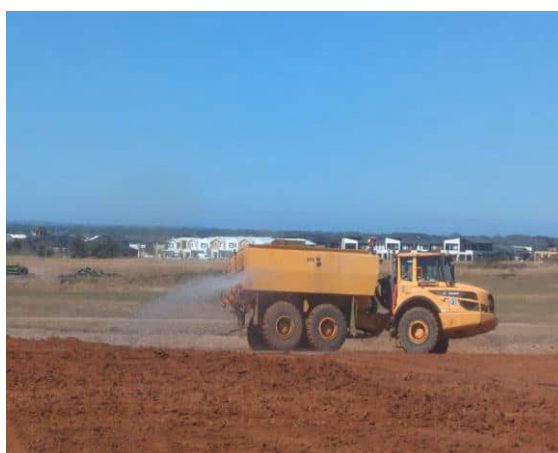
*Photograph 6: Water cart moisture conditioning*

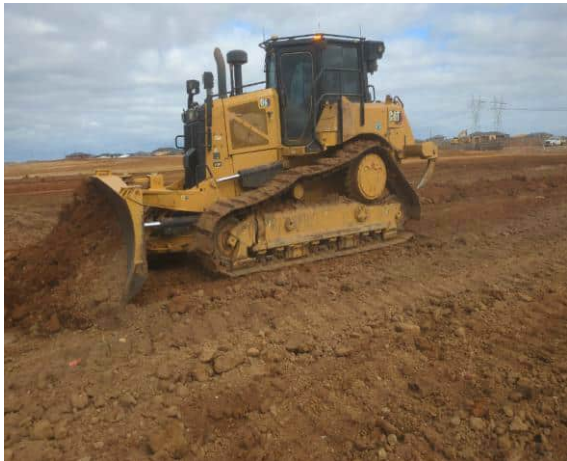
*Photograph 7: Bulldozer.*

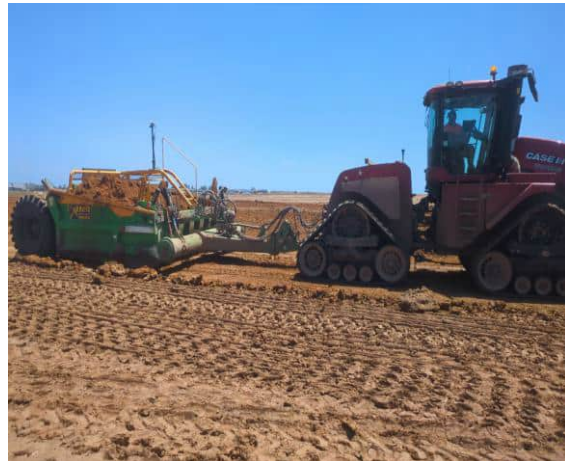
*Photograph 8: Scraper*

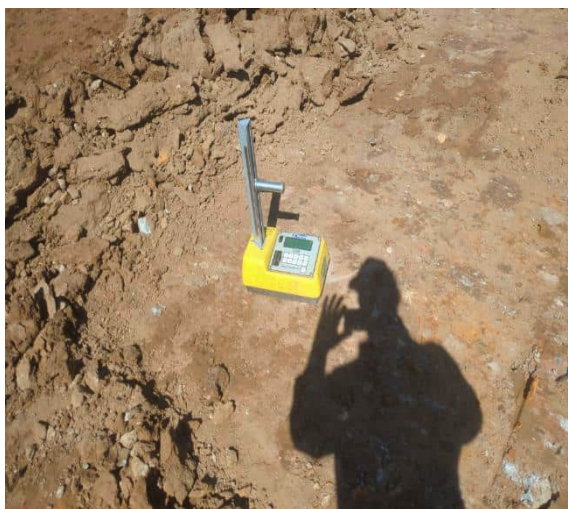
*Photo 9: Field density/moisture test*

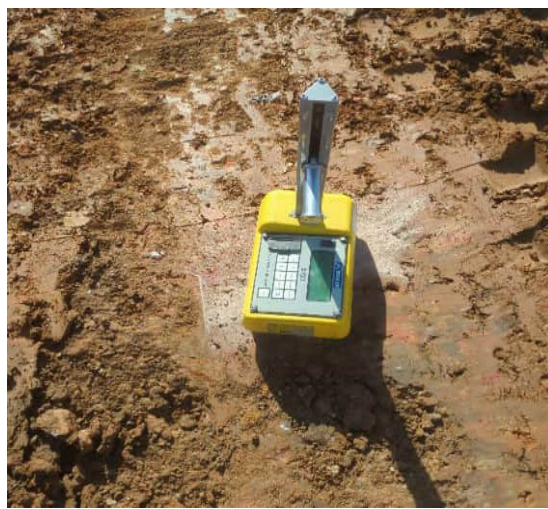
*Photo 10: Field density/moisture test*
