# **REPORT**

## **Level 1 Geotechnical Inspection and Testing Authority Services**

**Meridian Green Estate Clyde North  
Stage 51 Lots 5113, 5114 and 5124**

**Our Ref: 1091936.51.v1**

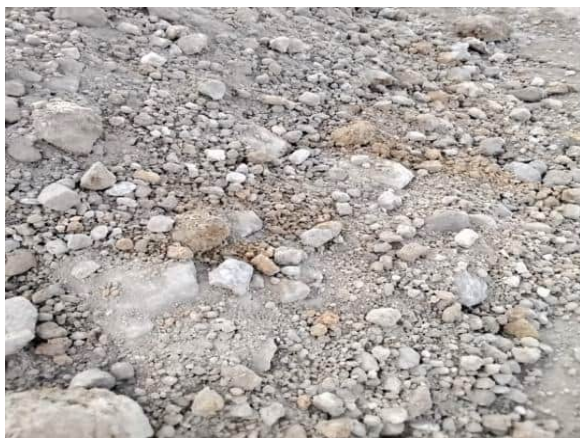
*Photograph 1: Typical on-site clay material*

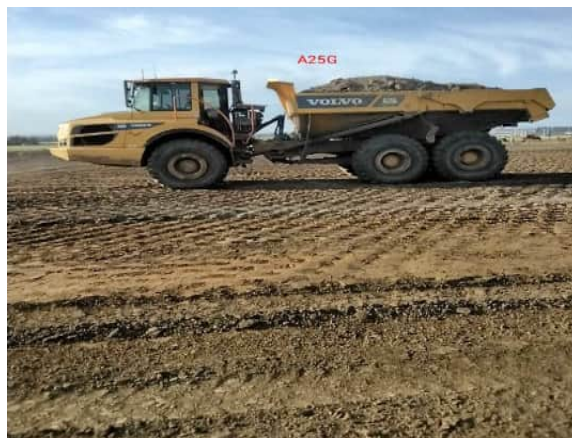
The laboratory test result indicates the fill material is a sandy CLAY of high plasticity and satisfied the requirements of the Specification.

*Photograph 2: Sandy CLAY Mottled Orange Brown*

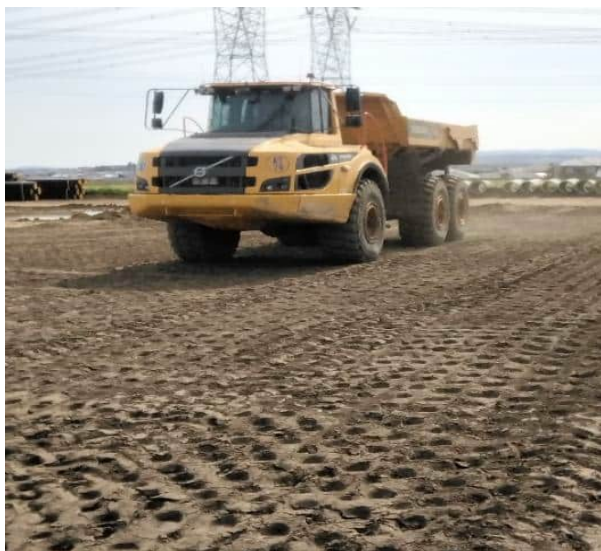
The subgrade inspections were performed in accordance with the Level 1 guidelines presented in AS3798–2007 Section 5.5. No soft spots or deflections were encountered during the inspections and the area was found to be firm and free of vegetation and other deleterious material.

*Photo 3: Subgrade assessment with Dump truck*

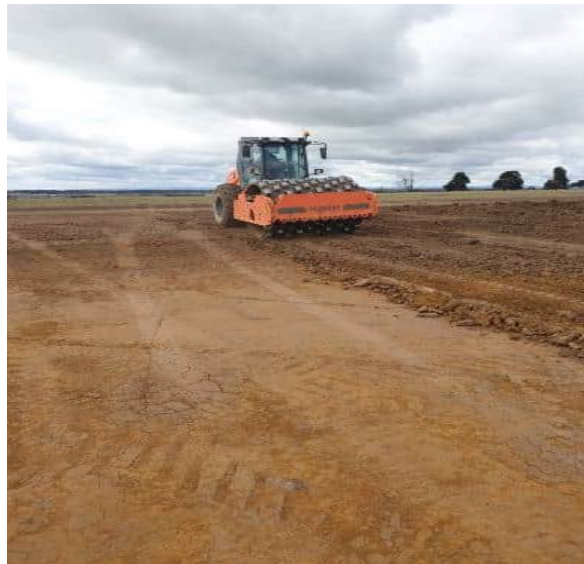
*Photo 4: Subgrade assessment with pad foot*

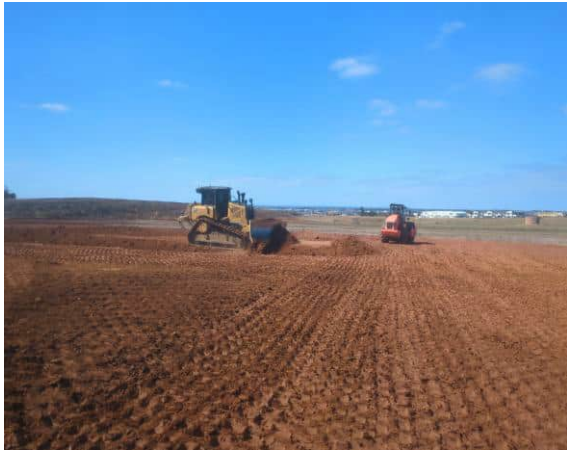
*Photograph 5: Pad foot Roller compacting.*

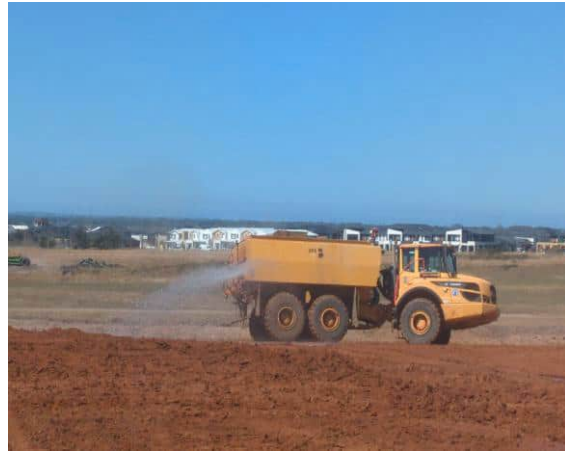
*Photograph 6: Water cart moisture conditioning*

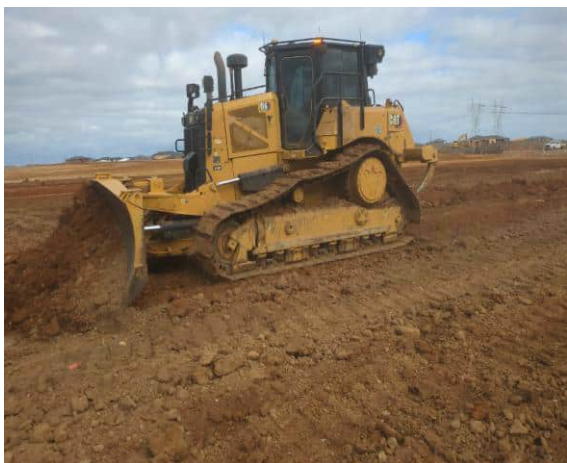
*Photograph 7: Bulldozer.*

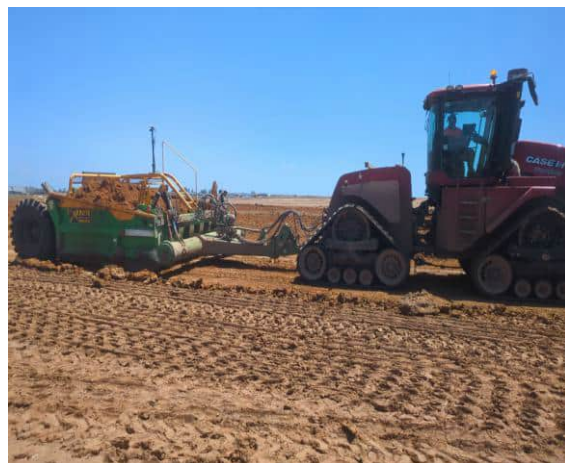
*Photograph 8: Scraper*

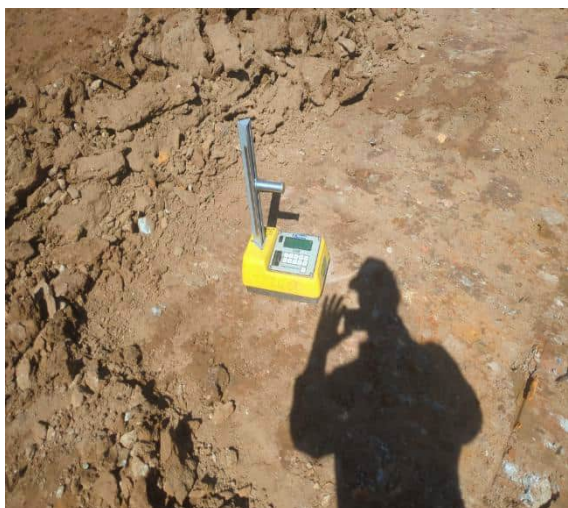
Three (3) tests were performed during the filling process. The tests achieved the recommended density or moisture ratio.

*Photo 9: Field density/moisture test*

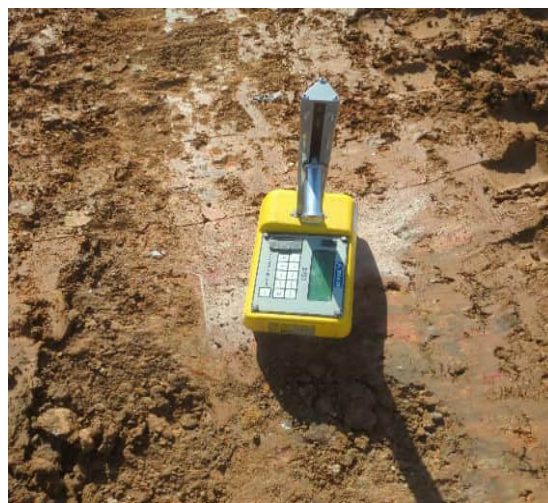
*Photo 10: Field density/moisture test*
