## **Level 1 Geotechnical Inspection and Testing Authority Services**

**Meridian Green Estate Clyde North  
Stage 54 Lots 5401 to 5435**

**13 November 2025**

**Our Ref: 1091936.054.v1**

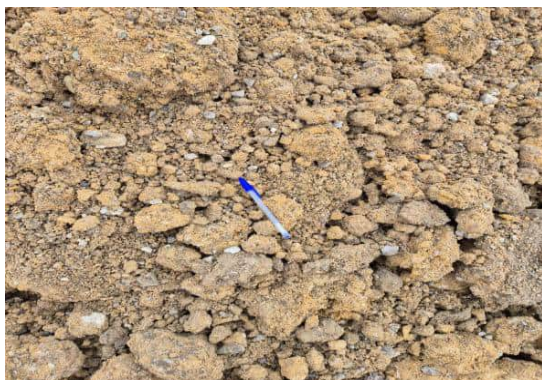
*Photograph 1: Typical on-site clay material*

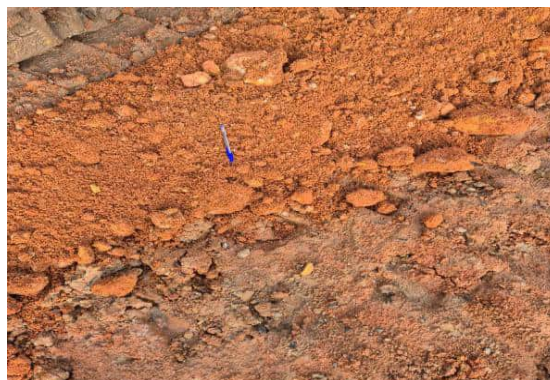
*Photograph 2: Sandy Mottled Orange Brown Clay*

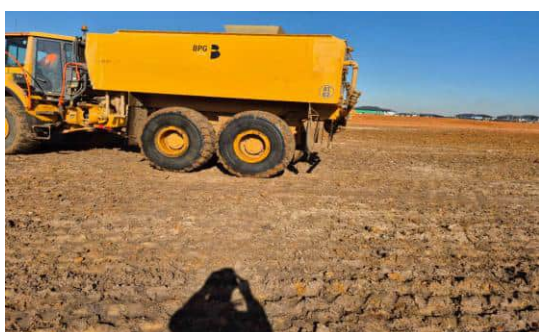
The subgrade inspections were performed in accordance with the Level 1 guidelines presented in AS3798–2007 Section 5.5. No soft spots or deflections were encountered during the inspections and the area was found to be firm and free of vegetation and other deleterious material.

*Photograph 3: Subgrade assessment with a loaded water cart.*

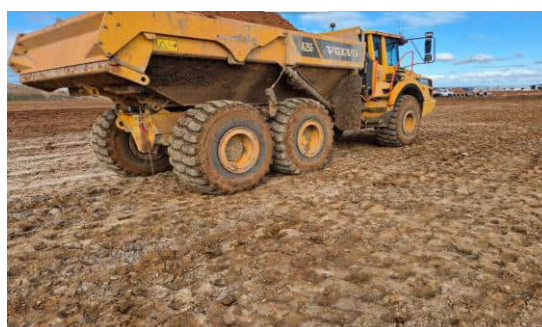
*Photograph 4: Subgrade assessment with a loaded dump truck*

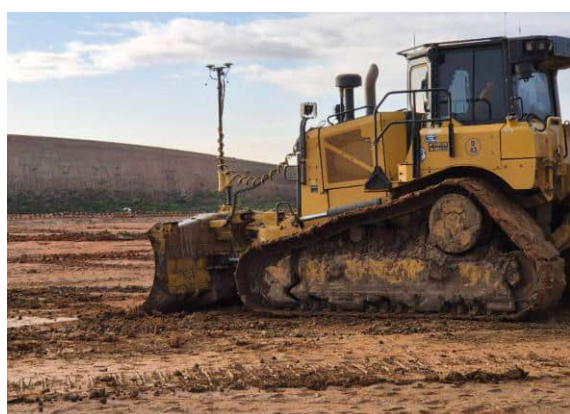
*Photograph 5: D6 Dozer spreading clay*

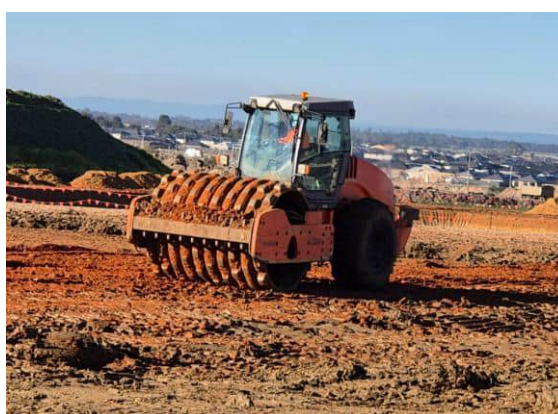
*Photograph 6: Pad foot compacting*

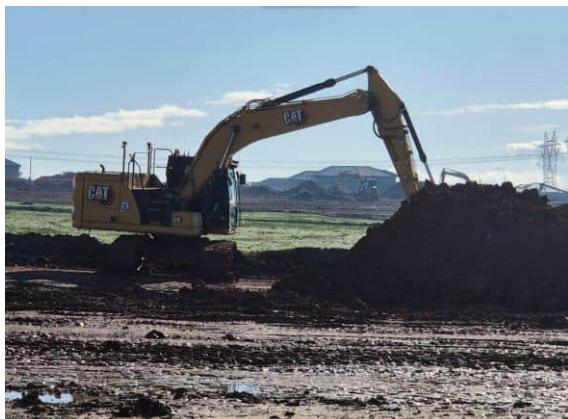
*Photograph 7: Excavator spreading clay.*

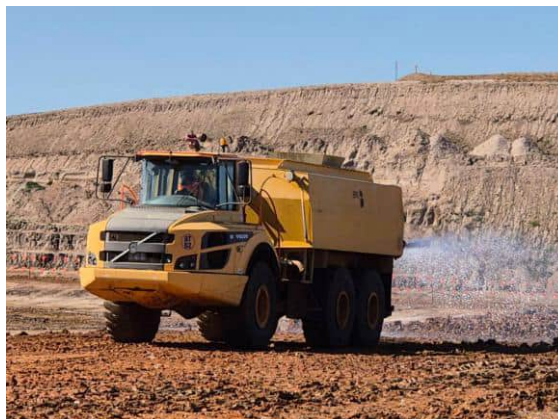
*Photograph 8: Water cart moisture conditioning*

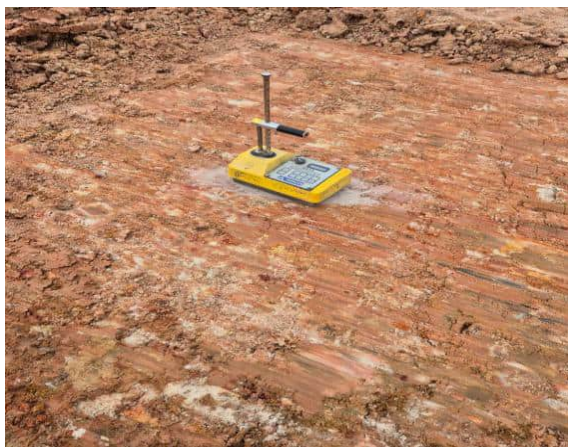
*Photograph 9: Field Density / moisture test*

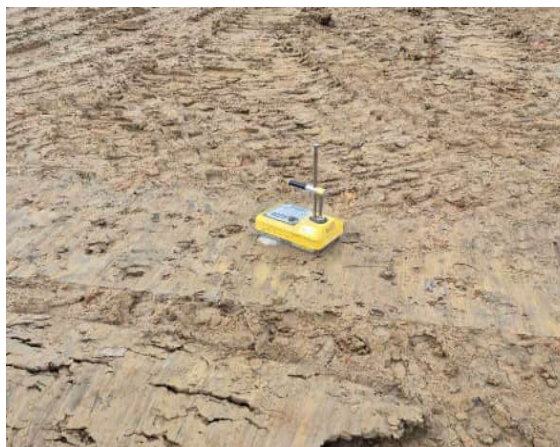
*Photograph 10: Field Density / moisture test*
