# **REPORT**

## **Level 1 Geotechnical Inspection and Testing Authority Services**

**Meridian Green Estate Clyde North  
Stage 53 Lots 5303 to 5338 and the  
Stage 53 Superlot**

**27 February 2026**

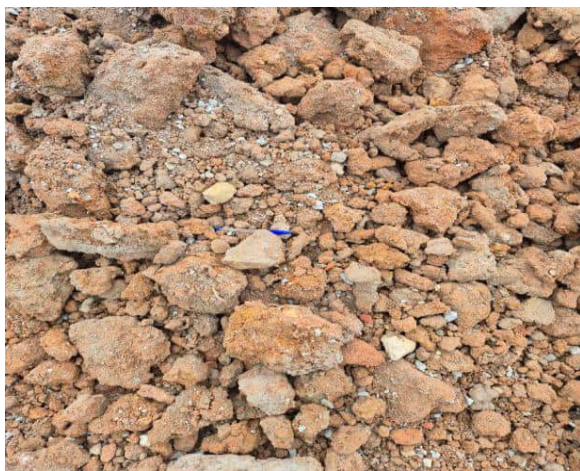
*Photograph 1: Typical on-site clay material*

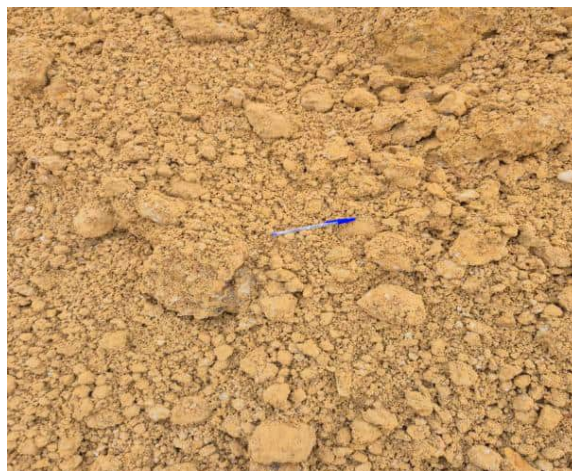
*Photograph 2: Sandy Mottled Orange Brown Clay*

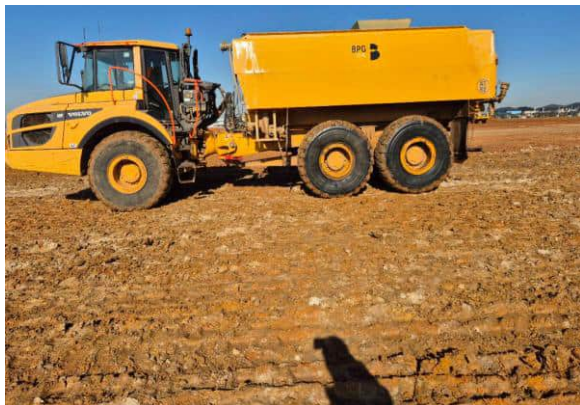
The subgrade inspections were performed in accordance with the Level 1 guidelines presented in AS3798–2007 Section 5.5. No soft spots or deflections were encountered during the inspections and the area was found to be firm and free of vegetation and other deleterious material.

*Photograph 3: Subgrade assessment with a loaded water cart.*

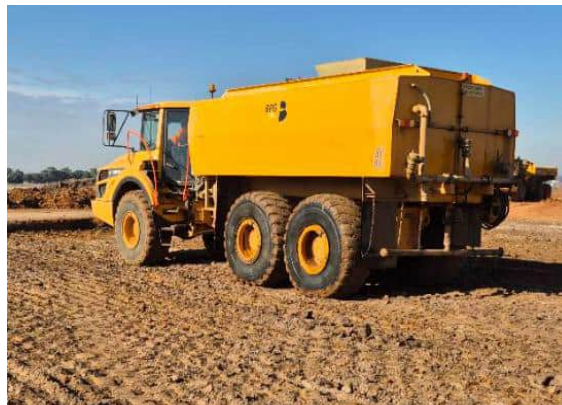
*Photograph 4: Subgrade assessment*

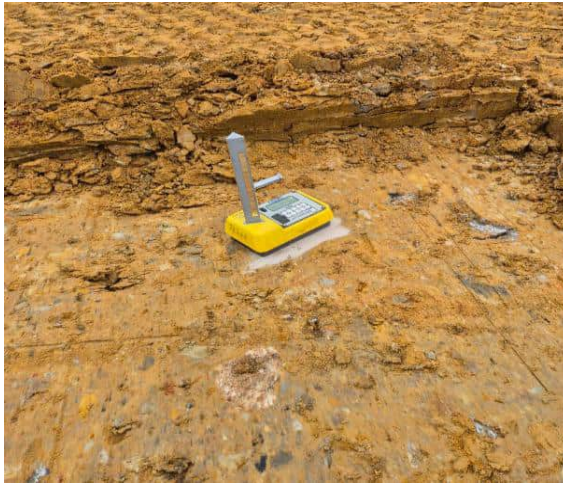
Eighty-Eight (88) tests were performed during the filling process. Twelve (12) of the tests did not achieve the recommended density or moisture ratio initially. The failed areas were reworked and retested accordingly. The retests returned passing density and moisture test results.

*Photograph 9: Field Density / moisture test*

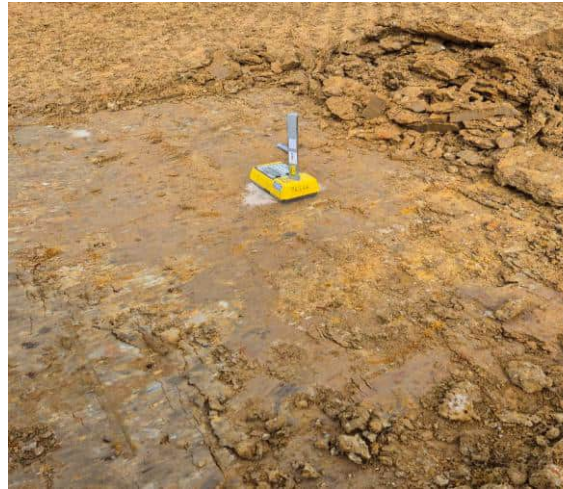
*Photograph 10: Field Density / moisture test*
