Level 1 Geotechnical Inspection and Testing Authority Services

**Meridian Green Estate, Clyde North
Stage 55, Lot's 5501 and 5504 to Lot 5534**

25/03/2026

Our Ref: 1091936.55.v1

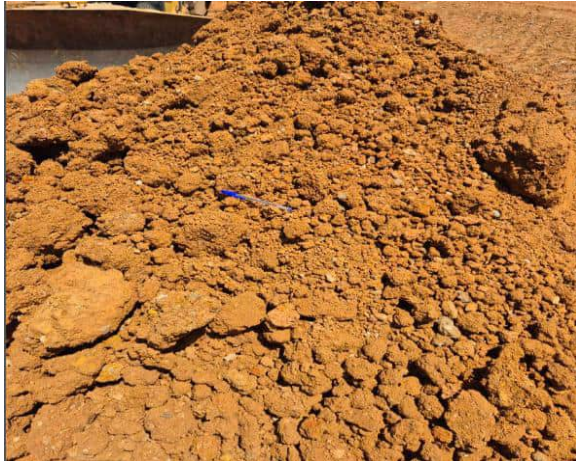
The laboratory test result indicates the fill material is a sandy CLAY of medium to high plasticity and satisfied the requirements of the Specification.

Photograph 1: Typical on-site clay material

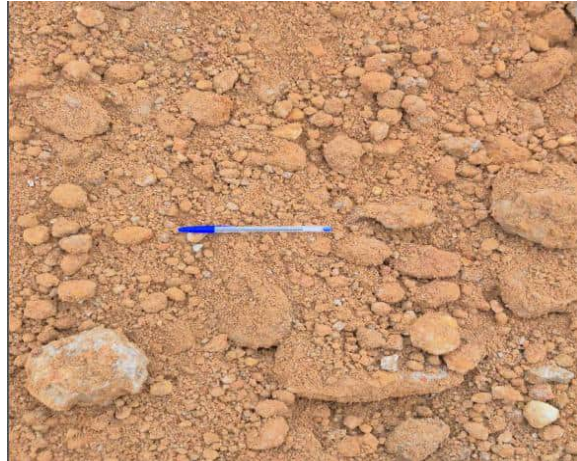
Photograph 2: Sandy CLAY Mottled Orange Brown

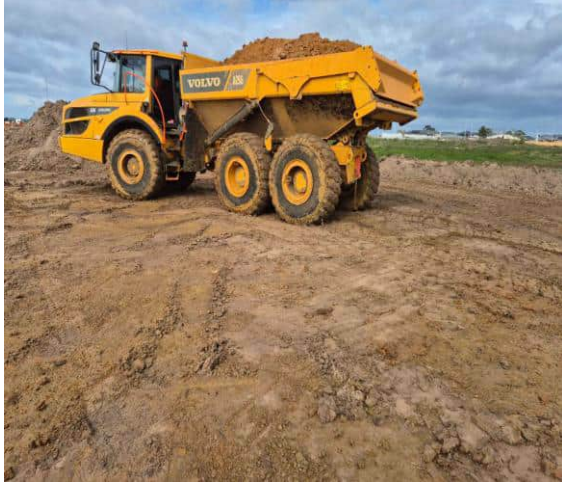
The subgrade inspections were performed in accordance with the Level 1 guidelines presented in AS3798–2007 Section 5.5. No soft spots or deflections were encountered during the inspections, and the area was found to be firm and free of vegetation and other deleterious material.

Photo 3: Subgrade assessment with Dump truck

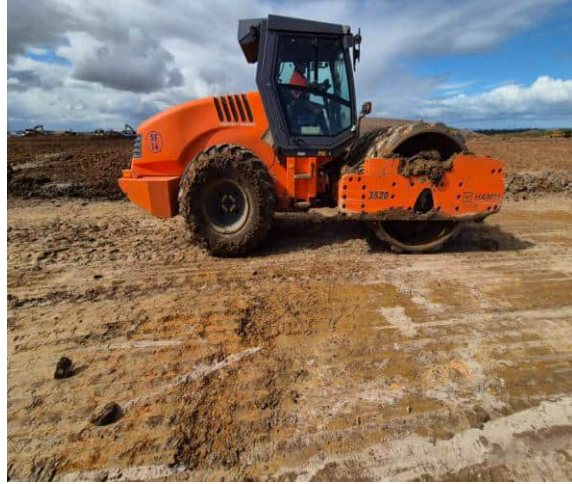
Photo 4: Subgrade assessment with pad foot

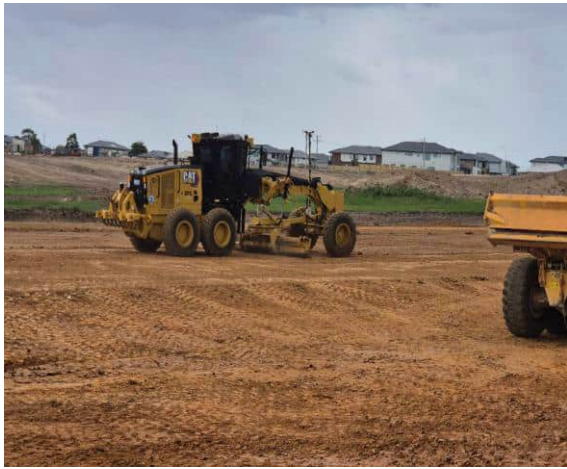
Photograph 5: Grader trimming surface

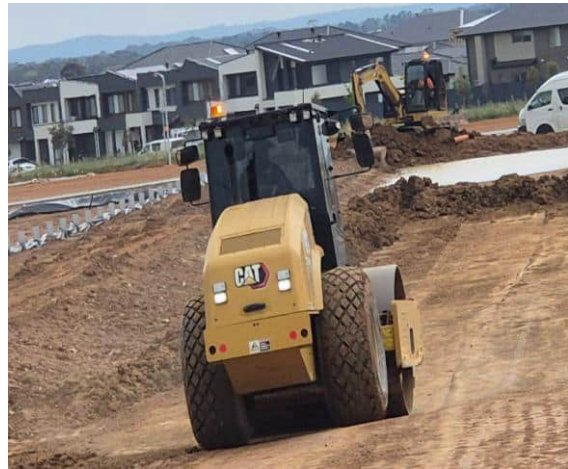
Photograph 6: Smooth drum roller

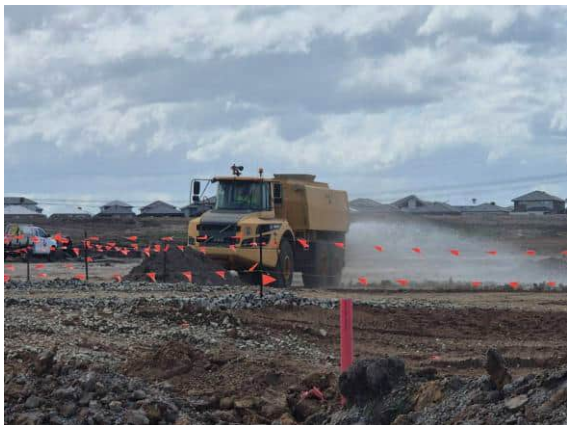
Photograph 7: Water cart conditioning clay

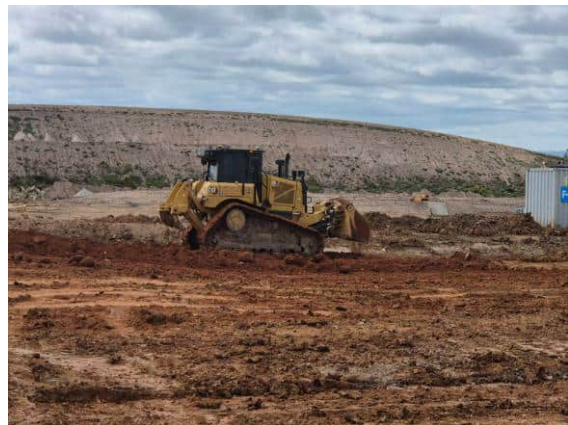
Photograph 8: D6 Dozer spreading fill

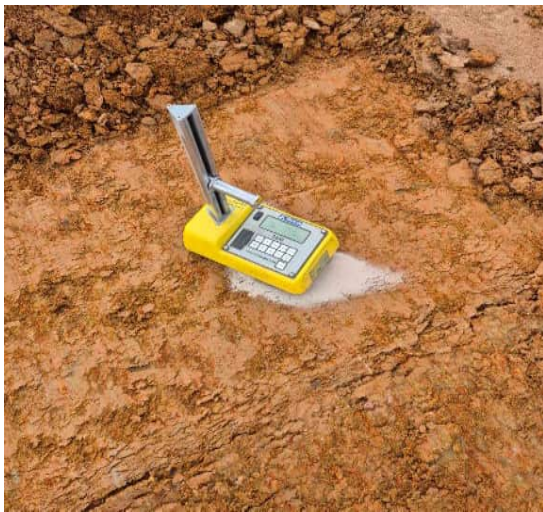
Photo 9: Field density/moisture test

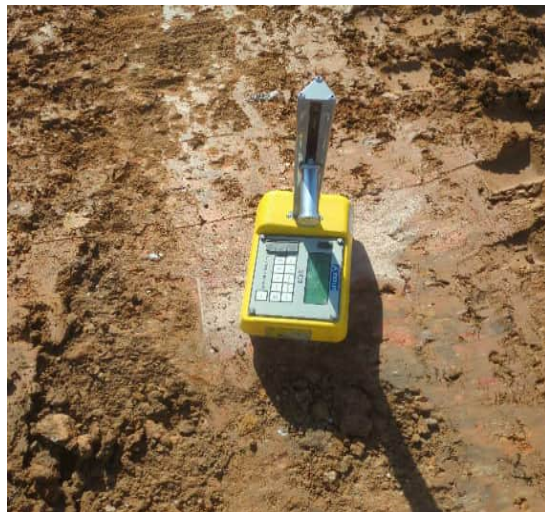
Photo 10: Field density/moisture test
