Level One Inspection and Testing Services

Meridian Estate Stage 20, Lots 2001 to 2033

Our Ref: 3807351.020.v1

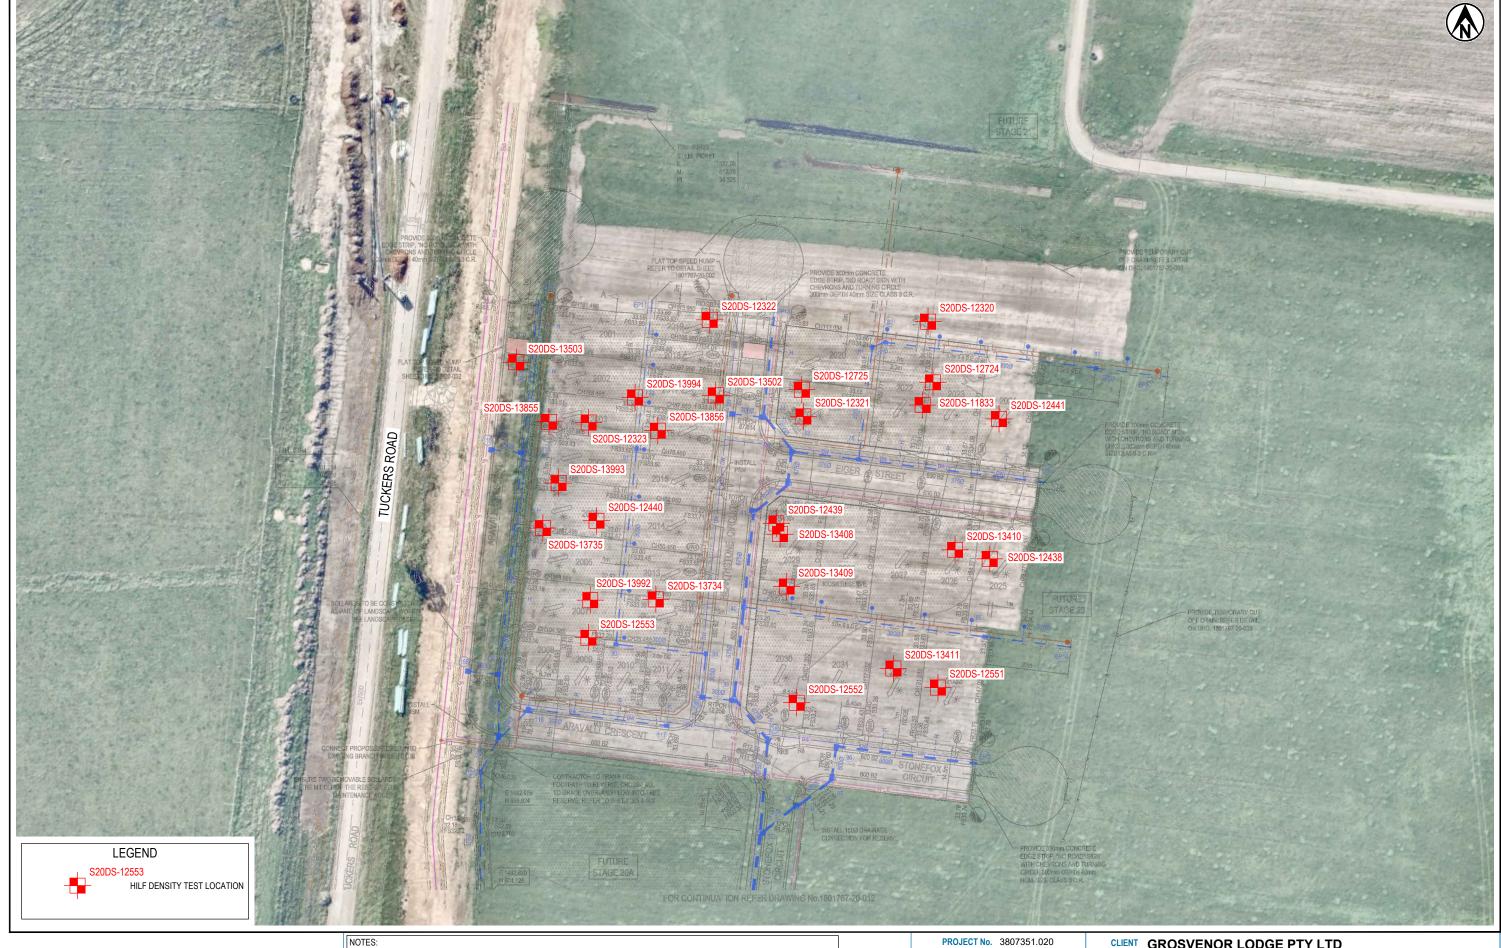
FIG No. FIGURE 01

Field density and moisture content testing was carried out using a calibrated portable density and moisture gauge in accordance with AS 1289.5.8.1. The HILF rapid compaction test was used for peak converted wet density determinations in accordance with AS 1289.5.7.1. Test locations were recorded using a handheld GPS unit. A site plan showing the field density test locations is provided in Appendix A.

TITLE LEVEL ONE HILF DENSITY TESTING

HILF DENSITY TEST PLAN

The results show that three (3) tests failed to meet the specification requirements for the project. The earthworks contractor was advised of the tests that failed and the fill relevant to those areas was reworked, reconditioned, re-compacted and subsequently retested. The final results show the tests achieved the specification requirements for the project.
