Level 1 Geotechnical Inspection and Testing Authority Services

**Meridian Green Estate, Clyde North
Stage 55, Lot's 5501 and 5504 to Lot 5534**

25/03/2026

Our Ref: 1091936.55.v1

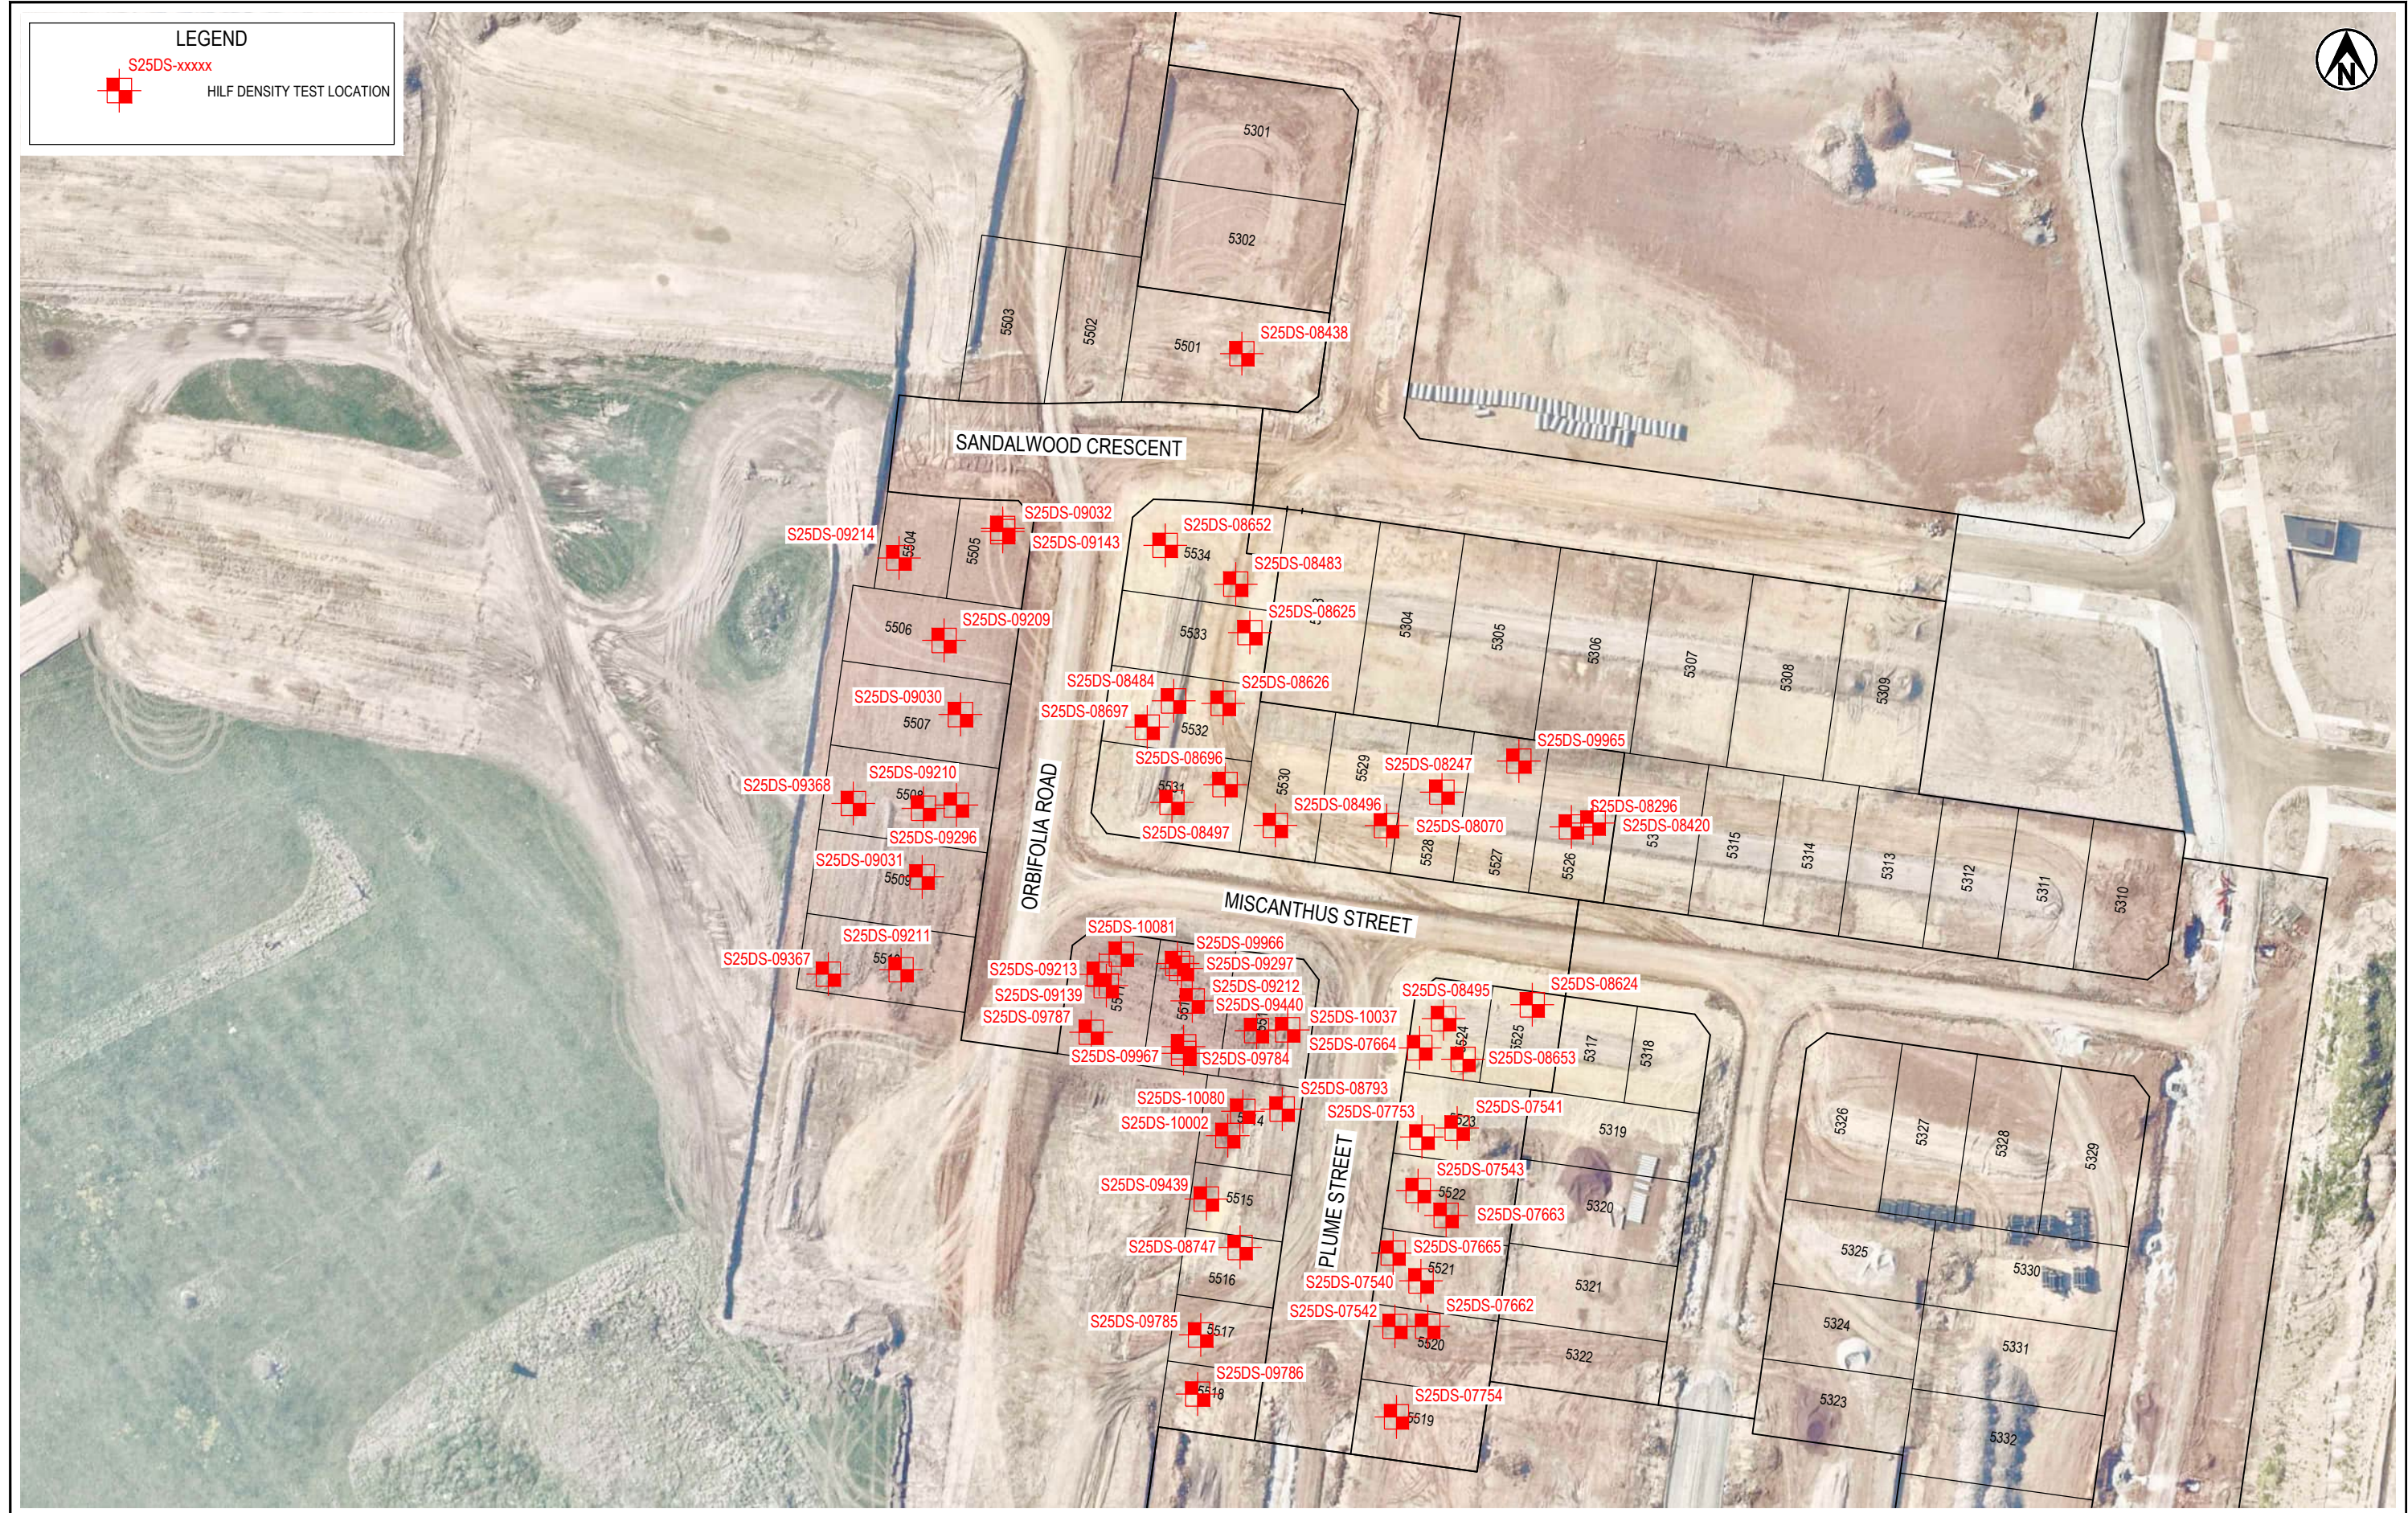
Appendix A Hilf Density Test location Plan

Fifty-Seven (57) tests were performed during the filling process. Five (5) of the tests did not achieve the recommended density or moisture ratio initially. The failed areas were reworked and retested accordingly. The retests returned passing density and moisture test results.
